West Stanislaus Resource Conservation District

Crows Landing Naval Base Easement

Annual Reserve Monitoring Report

Jamie McFarlin
11/1/2012

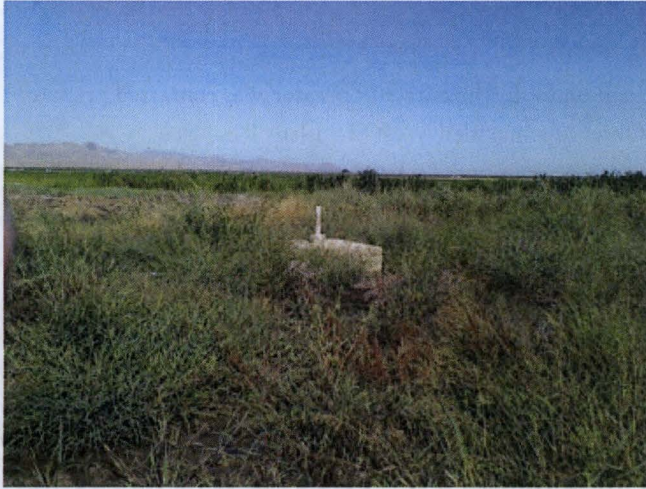
Figure 1. Well 6/8-8J, Field 3

Comments/Suggestions: It appears that there are two wells currently being utilized by tenants, one of which is 6/8-20G in field 10. The other is an unidentifiable well in field 3. Both well 6/8-20G and the second hypothesized well are being operated using a stationary diesel engine. Well 6/8-8J in field 3 is not in use, and has been capped. **Well 6/8-20C1 in field 8 is not in use, and has the acute problem of surface water surrounding the wellhead draining directly into the well, despite having been capped.** On the day of the monitoring event surface water was observed draining directly into the well, most likely through areas of the pipe that have deteriorated. This is a matter affecting groundwater quality that requires immediate attention.

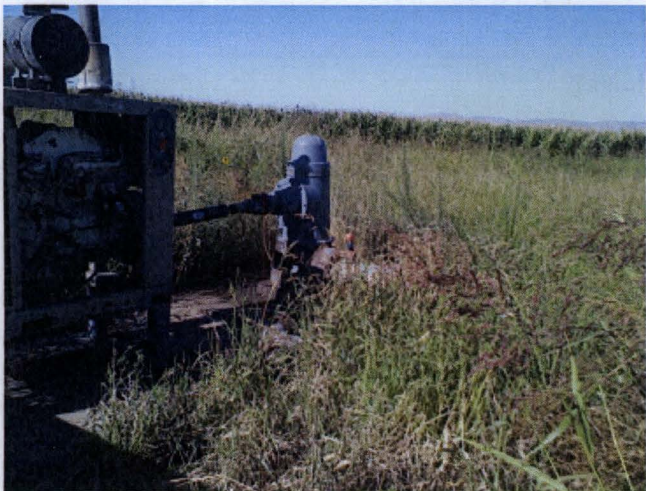
Figure 2. In-use Well in Field 3

Comments/Suggestions: Pumping is actively occurring on well 6/8-20G, field 10. No other previously identified wells are currently in use. There does, however, appear to be another well in operation on field 3 that could not be identified as well 6/8-8J, and is therefore hypothesized to be a new well. Both wells are being operated by a stationary engine.

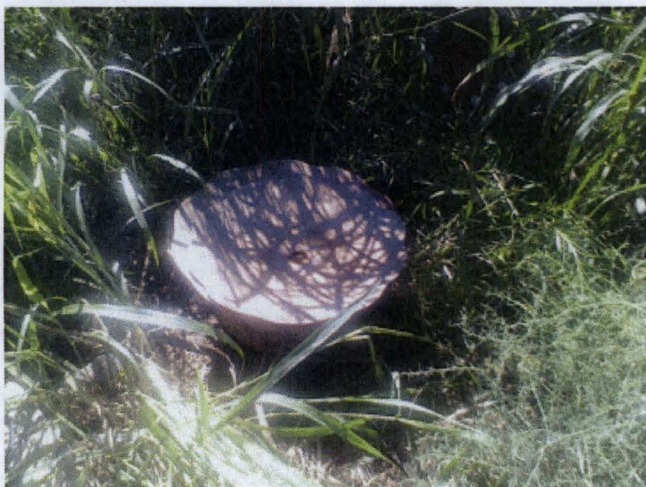
Wells on the property are mostly unused and highly exposed, with the exception of well 6/8-20G in field 10 which is currently being operated. Although it appears that the operator has capped unused wells on the property, the potential for unwanted contaminants (pesticides, fertilizers) to pollute groundwater directly through these old wells remains high. Well 6/8-20C1 in field 8 has the acute problem of surface water surrounding the wellhead draining directly into the well, despite having been capped. On the day of the monitoring event surface water was observed draining directly into the well, most likely through areas of the pipe that have deteriorated. This is a matter affecting groundwater quality that requires further investigation and immediate attention.

Figure 3. Well 6/8-20C1 in Field 8—Surface water observed draining directly into groundwater through areas where pipe has deteriorated.

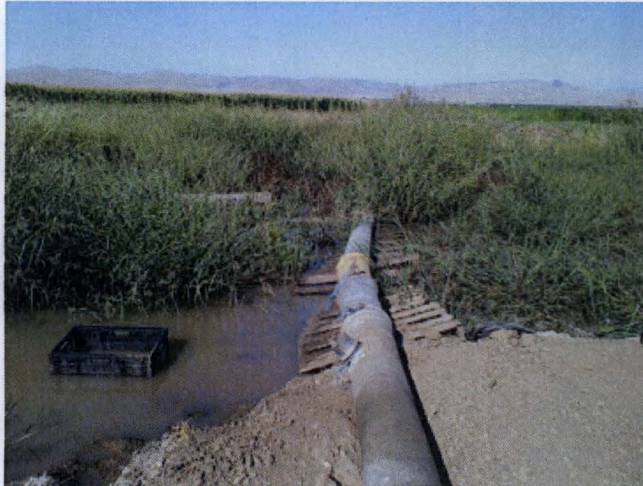
Figure 4. Drainage ditch congested by vegetation, trash, debris

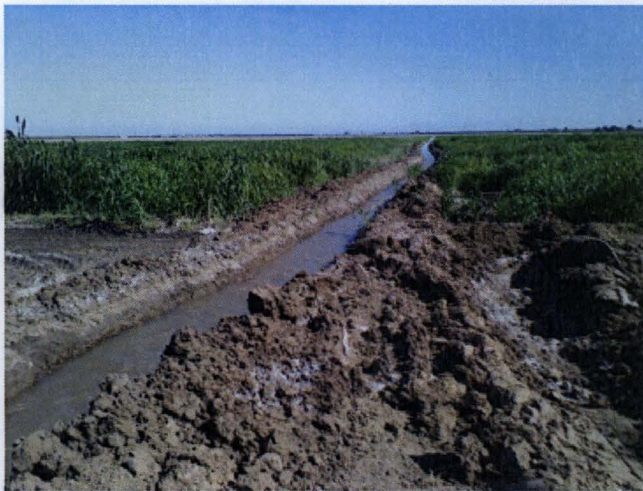
Figure 5. Well-managed and clean pickup ditch between fields

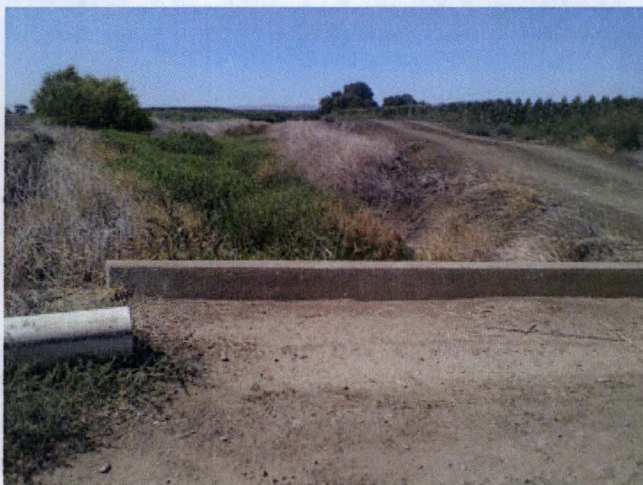
Figure 6. Drainage ditch with major reduction of water-holding capacity due to vegetation and sediment build-up

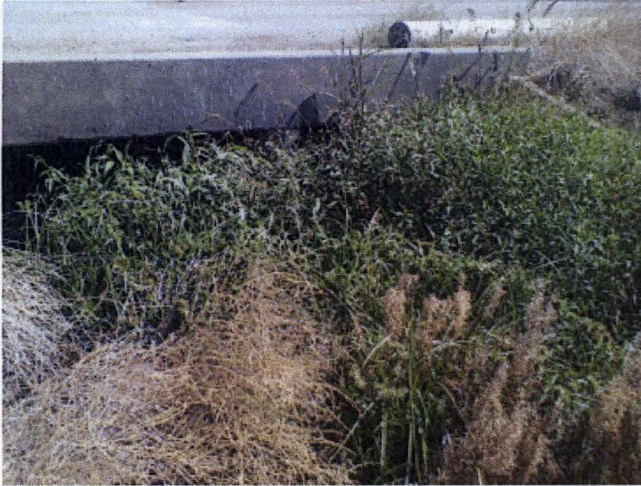
Figure 7. Culvert in-flow obstruction

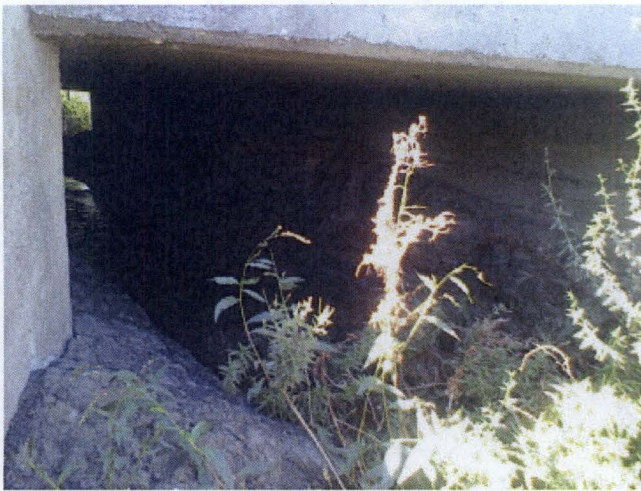
Figure 8. Culvert (same as Figure 7) demonstrating severe sediment build-up

Comments/Suggestions: Pickup ditches are in great need of maintenance, particularly in and around culverts. Sediment buildup and plant material are obviously impeding the flow of water through culverts, and in some parts of the ditches. The probability that culverts will not be able to handle any larger volumes of water (i.e. storm events) is very high.

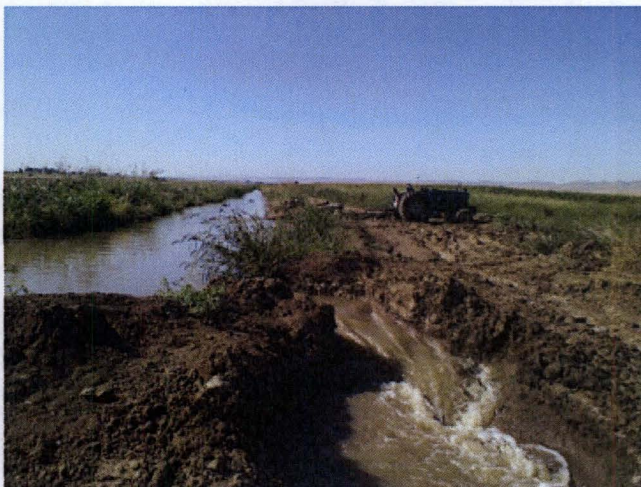
Figure 9. Operator using a stationary engine to pump irrigation water into pickup ditch from field

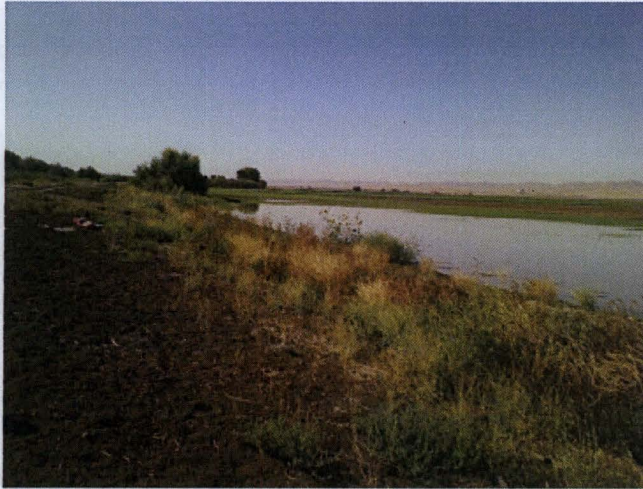
Figure 10. Flooding in fields 1&2, adjacent to Marshall Drain (upslope)

Comments/Suggestions: Production areas are being managed responsibly by tenants. At time of monitoring, fields 3-10 were in production. Fields 1 and 2 had some residue, properly managed. Producer is actively using a pumping system to direct water in the fields into drainage channels. There is major ponding of irrigation/storm water on fields 1 and 2 entirely due to neglected maintenance of adjacent Marshall Drain, see Sediment Basin/Tailwater Return System below.

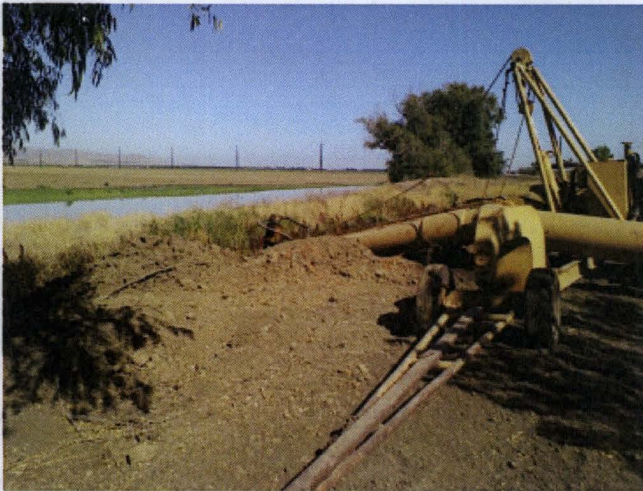
Figure 11. Operator pumping water from field 1&2 into the Marshall Drain

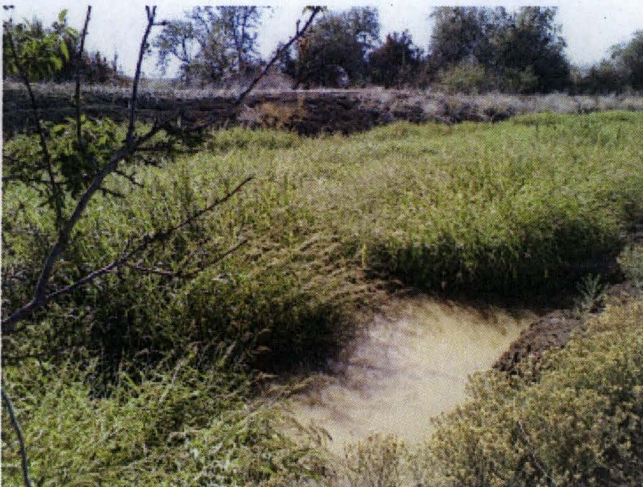
Creeks, culverts, and drains on the property are severely congested by sediment build-up and vegetation. One example of the problems that are occurring as a result is the condition of the Marshall Drain, adjacent to fields 1 and 2. The Marshall Drain is so elevated above the adjacent fields by sediment build-up that the natural direction of water flow is into the margins of fields 1 and 2. This is causing severe ponding, particularly in field 2. While the operator is actively pumping this water to manage the flooding, erosion is almost certainly occurring in those fields. Furthermore, water pumped back into the drain likely contains an increased sediment load and synthetic materials (pesticides, fertilizers). It is necessary that this drainage is restored to improve the water holding capacity and re-establish drain function on the property.

Figure 12. Marshall Drain, adjacent to fields 1 & 2—Note elevation of drain due to sediment build-up, as well as the establishment of vegetation.

Comments/Suggestions: Significant sediment build-up has elevated Marshall Drain above adjacent fields and has decreased overall water holding capacity of the drain, and is causing severe flooding on fields 1 and 2 (observed at time of monitoring). Tenant is actively pumping out ponding water from fields and back into the Marshall Drain, but does not appear to have the ability to do so in a way that remediates ponding. Heavy general weed presence apparent in drains/creek throughout the property further obstructs flow. Debris/trash and weeds are all also present in and around drains.

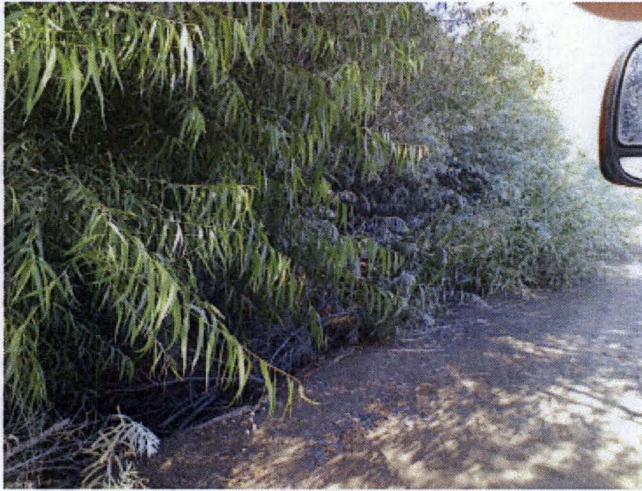
Figure 13. Marshall Drain, severely congested with vegetation and debris between field 2 and Wildlife Area

Comments/Suggestions: Marshall Drain/Little Salado Creek and its incorporated culverts are extensively congested by sediment build-up, woody debris, and weeds. Obstructions of flow will certainly result in stream diversion through adjacent fields during rains, as already observed in past winter and spring rains. Flow water that is diverted through the fields will (continue to) cause erosion of the field borders, sediment mass movement, and possible water contamination in Little Salado Creek.

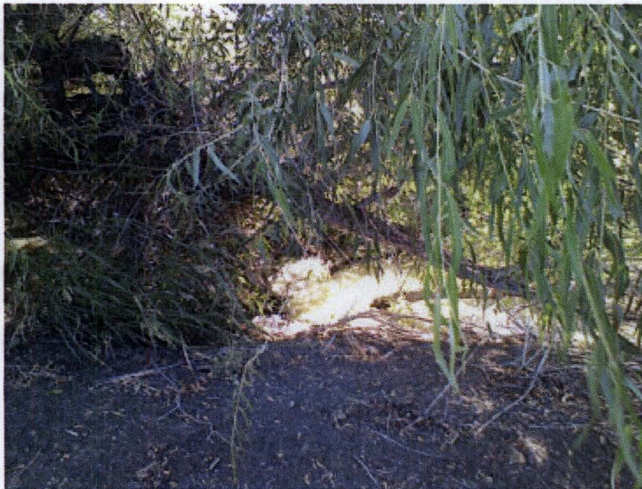
Figure 14. Marshall Drain, adjacent to Wildlife Area—Note surface of water is almost level with road.

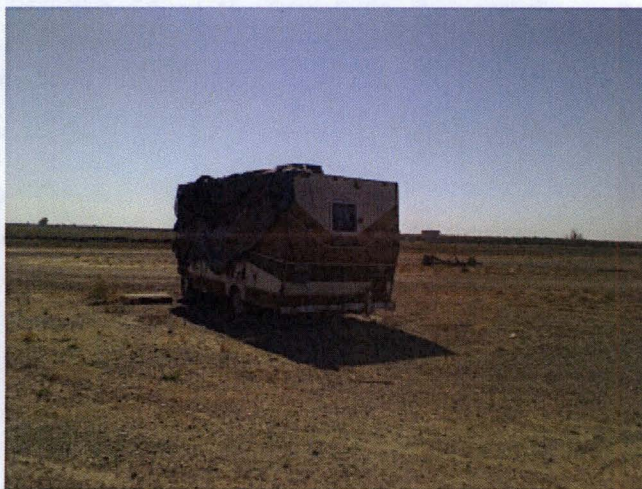
Figure 15. Structure and Garbage left on or near airstrip

Comments/Suggestions: A moderate amount of trash and abandoned structures (i.e. a trailer, equipment) can be found on and around the airstrip. Weeds are present along roadsides and the airstrip, but do not appear to be presenting a problem and do not appear to be creeping into agricultural fields.
