# Crows Landing Naval Base Easement

Annual Reserve Monitoring Report

West Stanislaus Resource Conservation District  
P.O. Box 193  
Patterson, CA 95363

7/19/2013

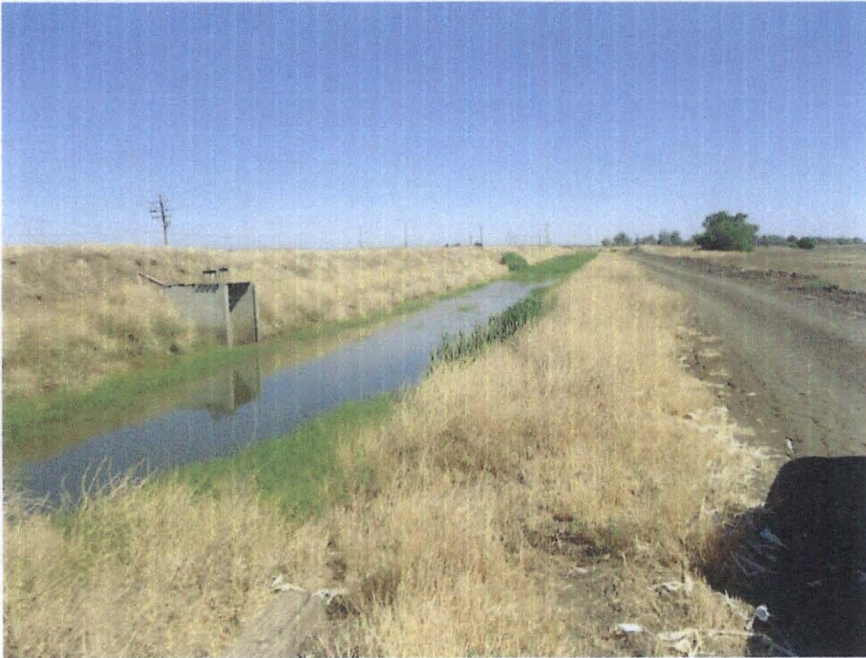
Figure 1. Marshall Drain, bordered by field 1

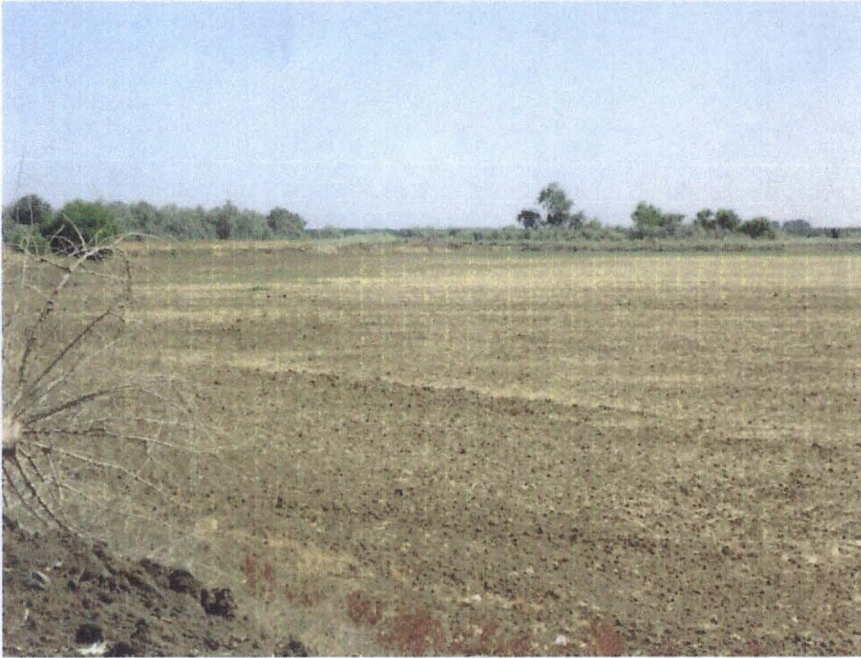
**Comments/Suggestions:** The position of Marshall Drain is elevated above adjacent fields. Some vegetation exists in parts of the channel but appears to have been improved upon considerably since the last monitoring tour. It is not known if the drainage has been dredged or what the actual water holding capacity of the drain is at this time. We understand that the county has been actively working to improve the condition of the Drain and Little Salado Creek since the 2012 report, and so may already be familiar with the capacity of the drain at this time. Observers recommend that the Marshall Drain on the northern end of the property be reviewed by someone with expertise if it has not been done so already. Although there was no flooding at the time of monitoring, all fields adjacent to the Marshall Drain look like they could still be susceptible to ponding during irrigation and especially during storm events. If flooding occurs in field 1, particularly during high water events, it could extend into Marshall Road and has potential to be hazardous to traffic on the road. Trash was not observed in or near the channel of Marshall Drain or Little Salado Creek. Some are present along the banks of Marshall Drain and Little Salado Creek. At this time, irrigation is occurring and observers did witness tailwater being channeled into pickup ditches.

Figure 2. Fields 1 and 2, slope demonstrating elevated position of Marshall Drain in bottom left corner of image

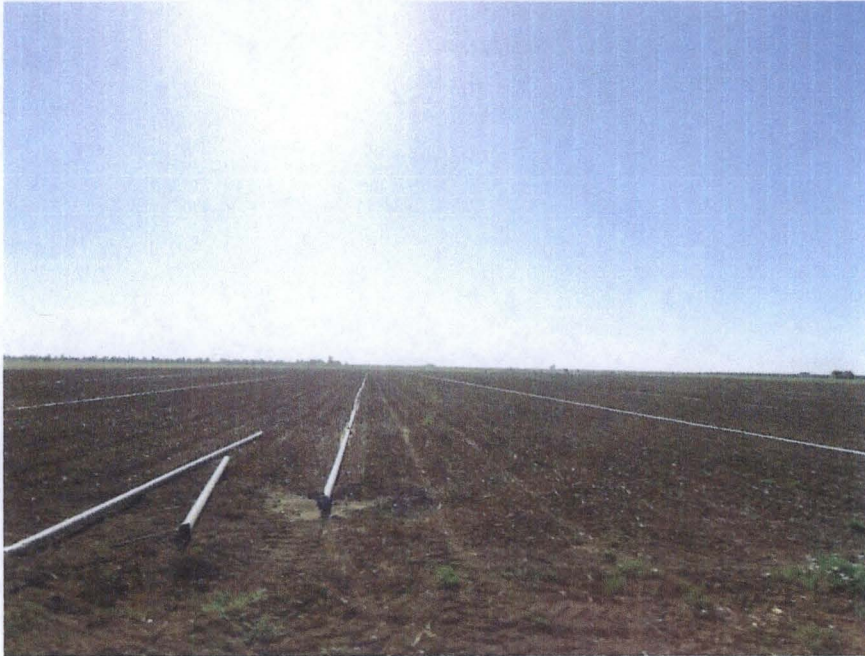
Figure 3. Field 3, being prepared to be irrigated by well 6/8-8J

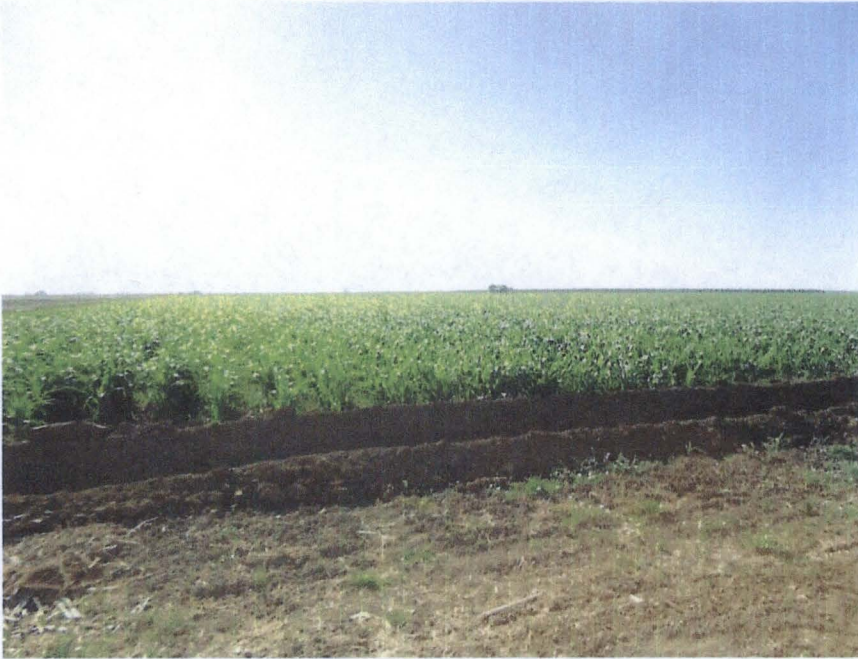
1. Airstrip  
Garbage and debris no longer present on airstrip, and was thoroughly cleaned following the last report
2. Fields  
Operator is responsibly managing fields, with minor weed presence on field margins (see figure 15, figure 17), and apparently active management of irrigation water (see figure 4, figure 5). Crop residue is present in fields not currently in production.

Figure 4. Production area with corn, irrigation drainage (pickup ditch)

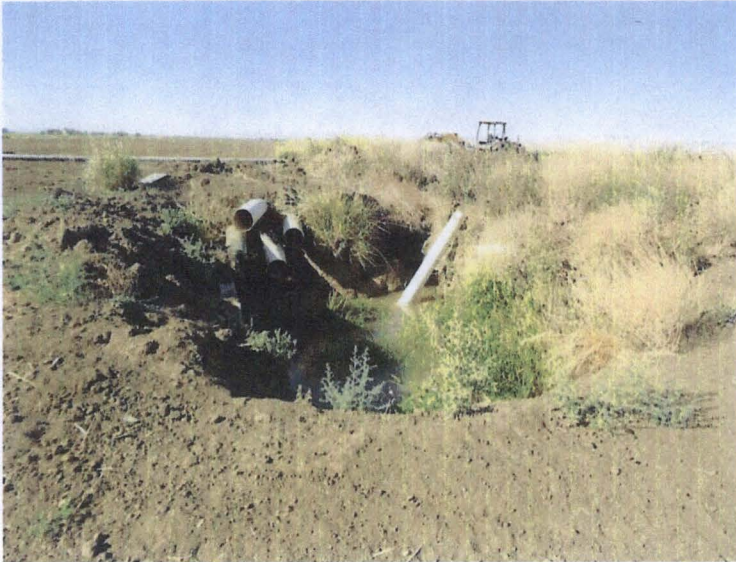
Figure 5. Irrigation drain, weeds

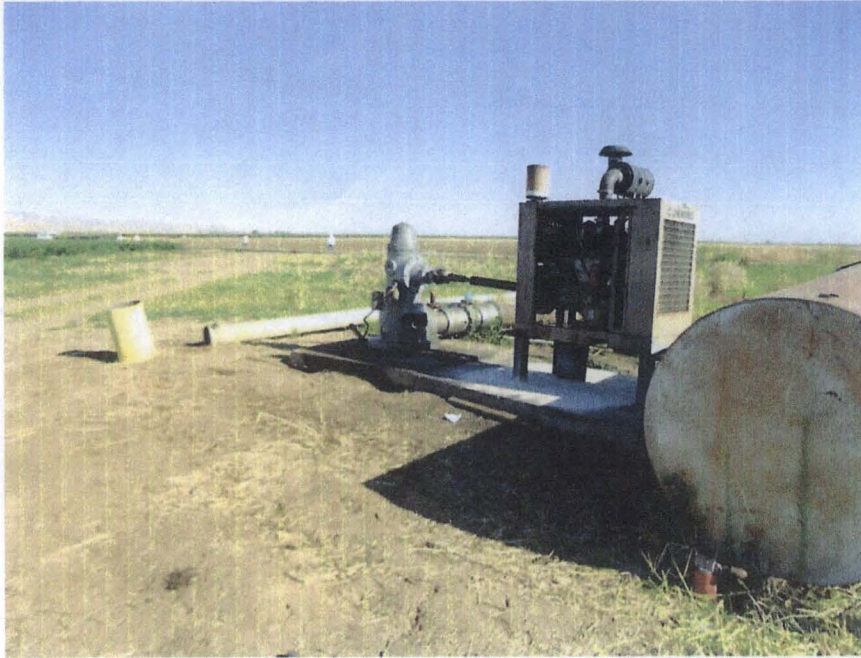
Figure 6. Well 6/8-8J

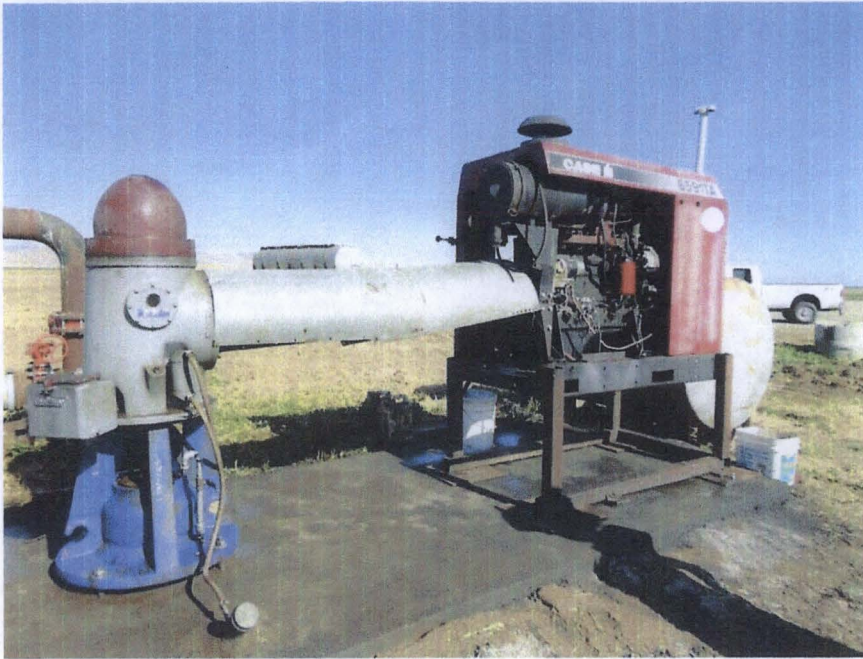
Figure 7. Well 6/8-20G

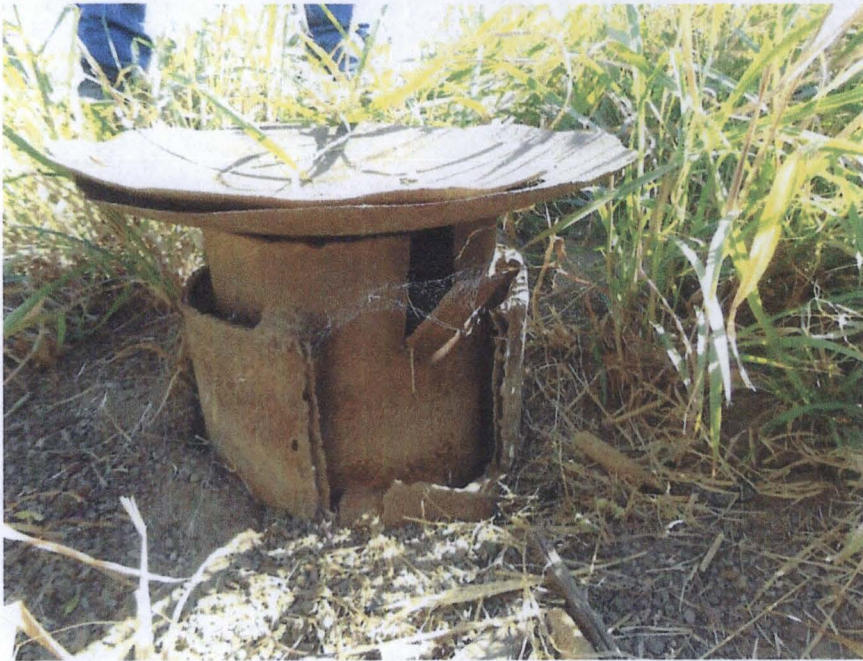
It was reported in 2012 that the potential for unwanted contaminants to enter groundwater through irrigations wells on the property was high. Although the same potential for groundwater contamination continues to exist at this moment in well 6/8-20C1, it is our understanding that all irrigation wells are under supervision by those with expertise in wells at the Stanislaus County Department of Environmental Resources, and notable actions have been taken or are in process to remedy the risk of groundwater contamination. Again, well 6/8-20C1 continues to provide a direct conduit to groundwater but the tenant has reported to the Stanislaus County Department of Environmental Resources that he would like to rehabilitate the well and convert it to an operational system. The rehabilitation is being scheduled for August of 2013. It is suggested that this well continue to be monitored until it has been fully rehabilitated.

Figure 8. Well 6/8-20C1

4. Wells  
Wells are under the supervision of Stanislaus County Department of Environmental Resources. At the moment well 6/8-20C1 continues to present an environmental risk, but is scheduled to be rehabilitated in August 2013. It is suggested that the county or property operator consider fencing all wells on the property to protect well areas.

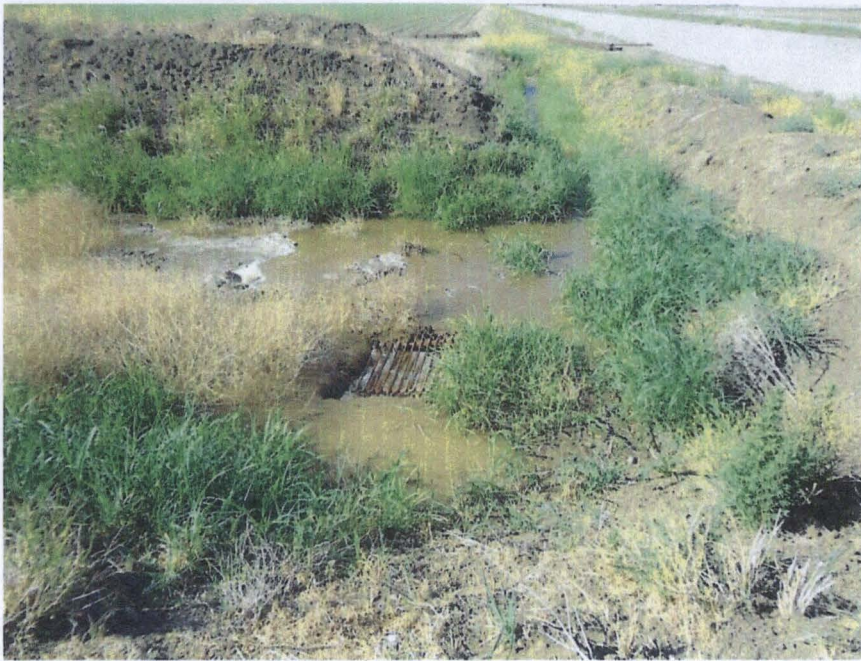
Figure 9. Irrigation drain, adjacent to field 10

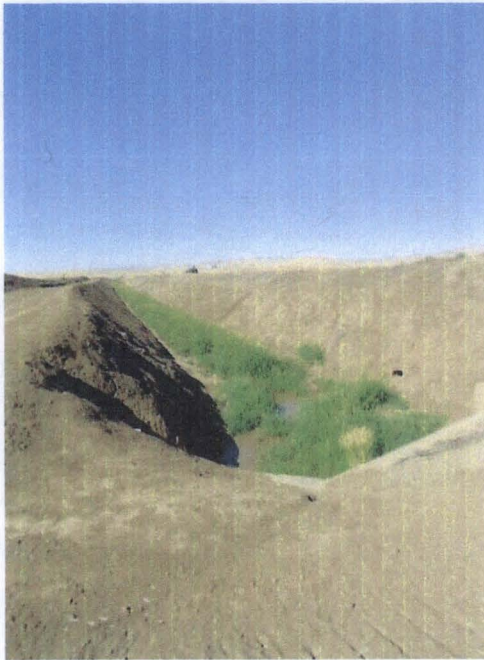
3. Marshall Drain, pickup ditches and culverts, Little Salado Creek.  
Little Salado Creek appears to have been improved following the 2012 report (see figure 10). Some waterways are congested by sediment build-up and vegetation, especially culverts adjacent to production areas, and could present a risk for some flooding into production areas as well as the potential to carry sediment downstream (see figure 11, figure 12). This is likely an ongoing point of note as sediment will continue to be regularly introduced into these waterways during irrigation and storms. The elevation of Marshall Drain (see figure 1, figure 2) on the northern end of the property, and its proximity to Marshall Road, is hypothesized to present the potential that, in high water events, water could flood out of the drain and into adjacent property areas, and could potentially flood into Marshall Road. It is suggested that this hypothesis be assessed by a party with real expertise in drainages if it has not been done so already.

**Comments/Suggestions:** Little Salado Creek appears to be in good condition, and was reported to have received considerable attention since the last monitoring tour. Vegetation in the channel near the Boy Scout Wildlife Area appears to have been thinned considerably since the last monitoring report as well. However, monitors noted that some vegetation in channel near the Boy Scout Wildlife Area (see figure 13, figure 14) might still be causing some obstruction, and the actual sediment build-up in the channel is unknown by monitors. With this in mind, it is suggested that the water-holding capacity of the drainage particularly near the Boy Scout Wildlife Area be reviewed by a party with expertise in this area, if it has not been done so already. Weeds are present in the wildlife habitat area and near the channel.

Figure 10. Little Salado Creek

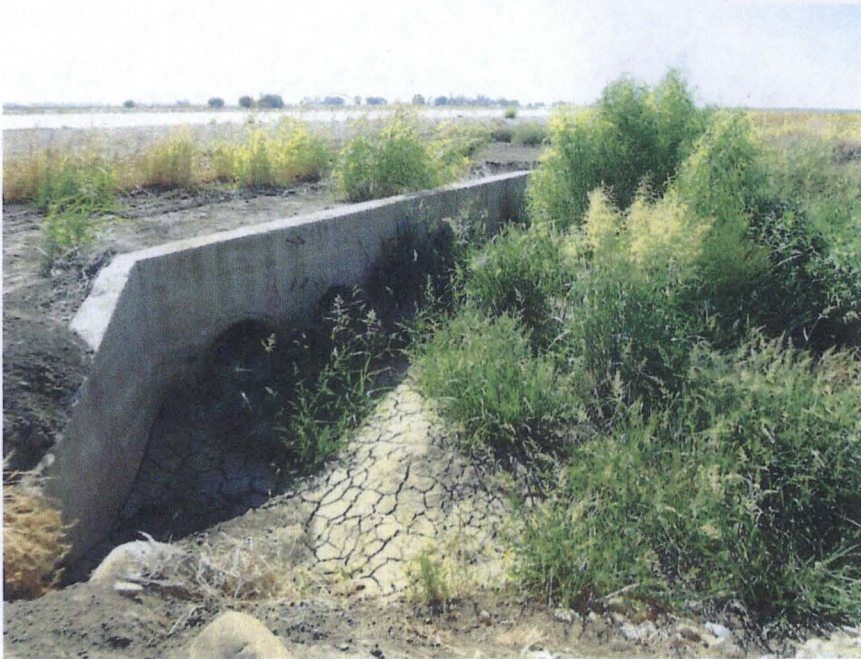
**Comments/Suggestions:** Irrigation water pickup ditches in and around culverts look to be in need of maintenance. Culverts viewed at the time of monitoring on the property appeared moderately congested by sediment build-up, woody debris, and weeds (see figure 11, figure 12). It is hypothesized that these obstructions of flow could result in stream diversion through adjacent property areas during heavy irrigation events and especially during large storm events. It was verbally reported to monitors that there is plan for improvement in these areas by the tenant in cooperation with the county. However, monitors are unaware of the details regarding this matter and did not consult the tenant on the issue, and so cannot comment further than acknowledging the current presence of sediment and weeds in the culvert.

Figure 11. Drainage culvert, moderately congested (near Airstrip)

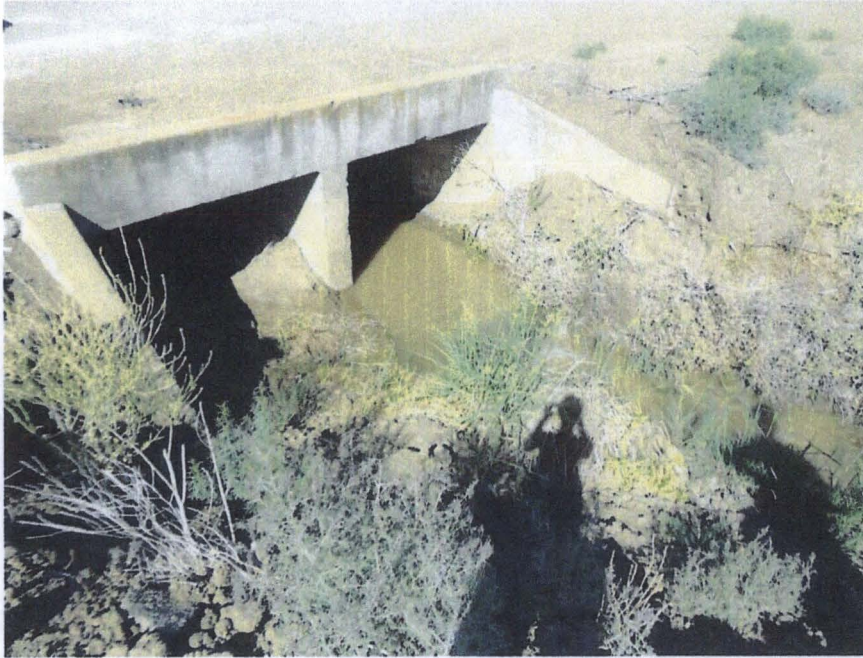
Figure 12. Pickup ditch culvert, sediment build-up (near Airstrip)

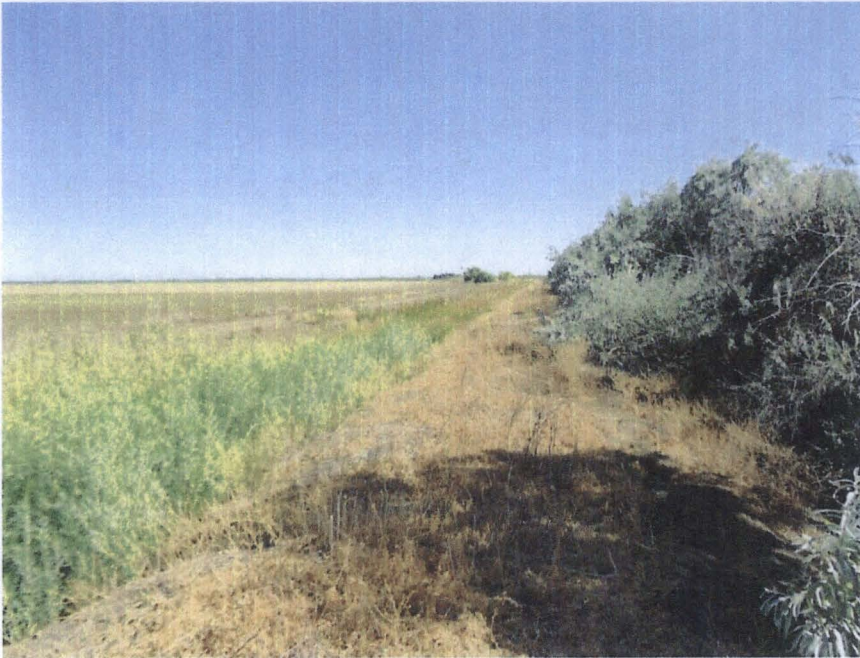
Figure 13. Marshall Drain, viewed from habitat area looking towards Marshall Road

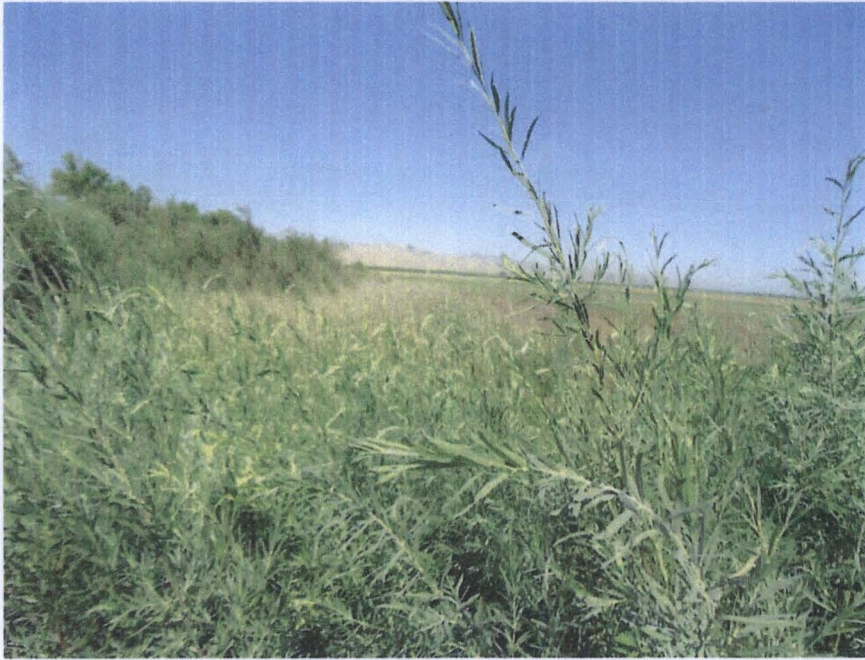
Figure 14. Marshall Drain and habitat area

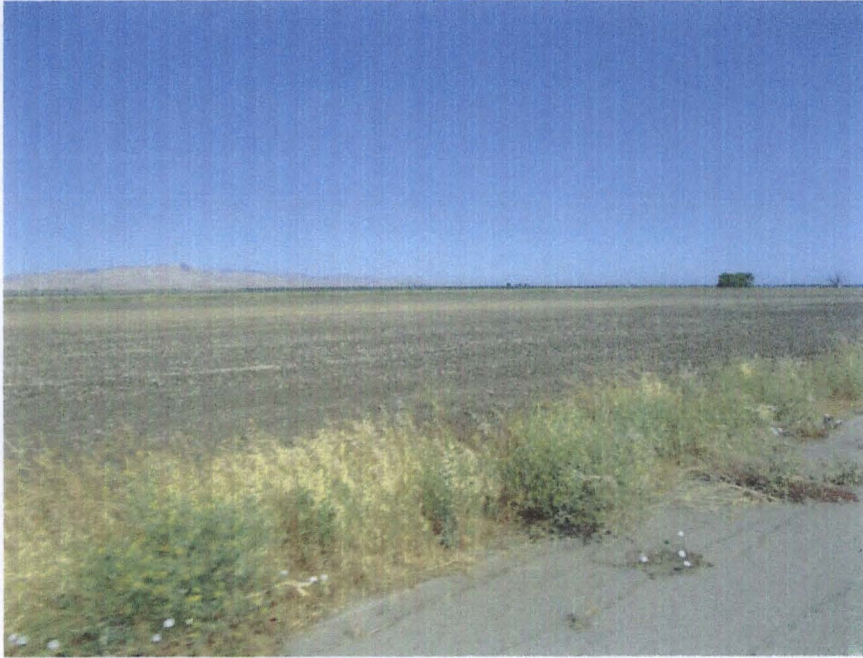
Figure 15. Weeds along production area

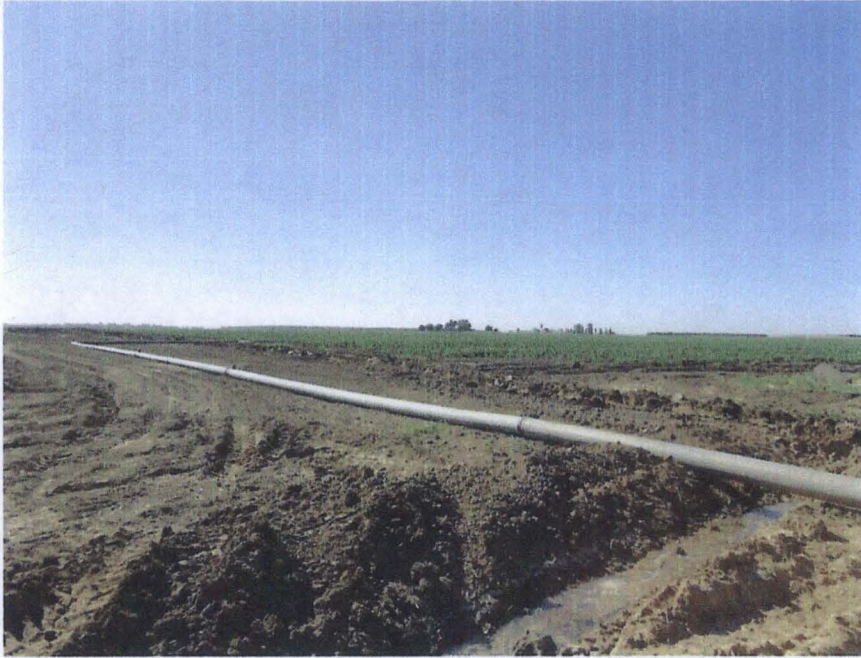
Figure 16. Irrigation line between fields 2 and 3

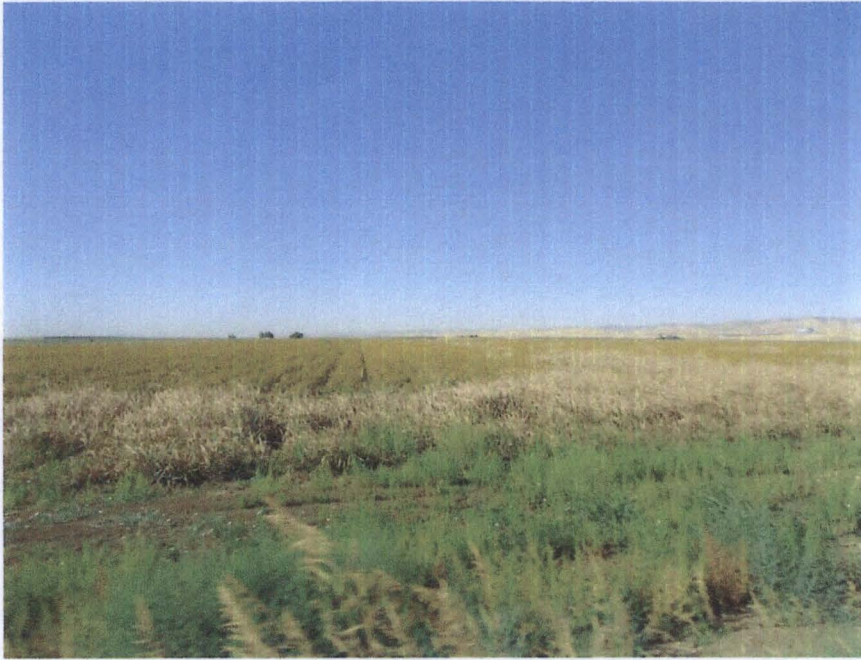
Figure 17. Field 6 safflower, bordered by weeds
