West Stanislaus Resource Conservation District

Crows Landing Naval Base Easement

Annual Reserve Monitoring Report

10/21/2014

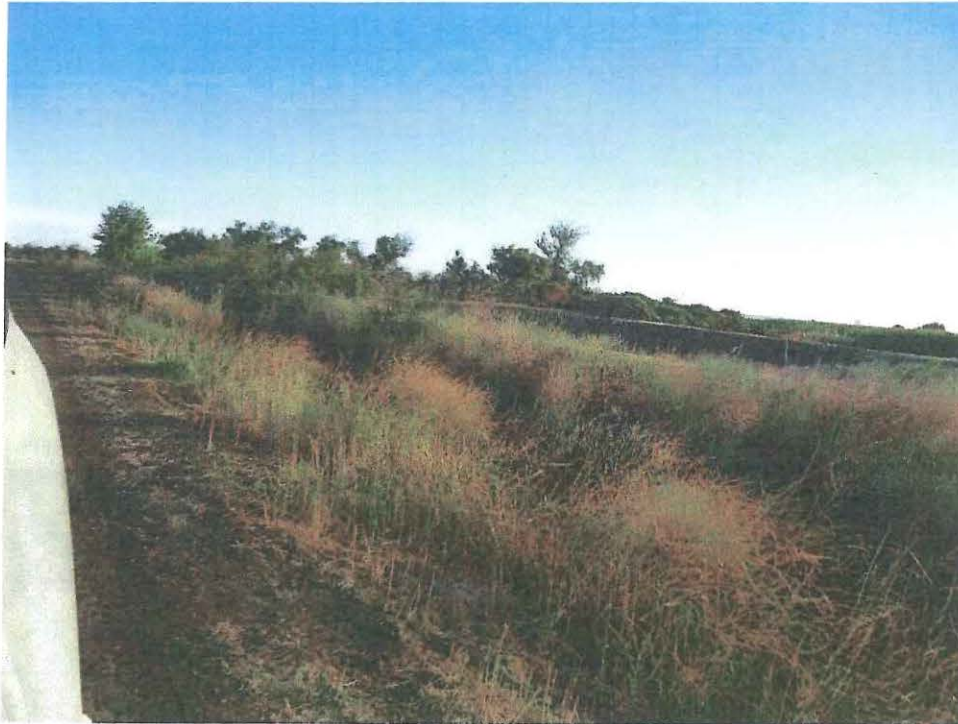
Comments/Suggestions: The position of Marshall Drain is elevated above adjacent fields. Some vegetation exists in parts of the channel but appears to have been improved upon considerably since the last monitoring tour. It is not known if the drainage has been dredged or what the actual water holding capacity of the drain is at this time. We understand that the county has been actively working to improve the condition of the drain and Little Salado Creek since the 2013 report, and so may already be familiar with the capacity of the drain at this time. Observers recommend that the Marshall Drain on the northern end of the property be reviewed by someone with expertise if it has not been done so already. Although there was no flooding at the time of monitoring, all fields adjacent to the Marshall Drain look like they could still be susceptible to ponding during irrigation and especially during storm events. If flooding occurs in Field 1, particularly during high water events, it could extend into Marshall Road and has potential to be hazardous to traffic on the road. Trash was not observed in or near the channel of Marshall Drain or Little Salado Creek. Some trash was present along the banks of Marshall Drain and Little Salado Creek. At this time, irrigation was not observed and we were unable to witness tailwater being channeled into pickup ditches.

Figure 1. Marshall Drain, bordered by Field 1

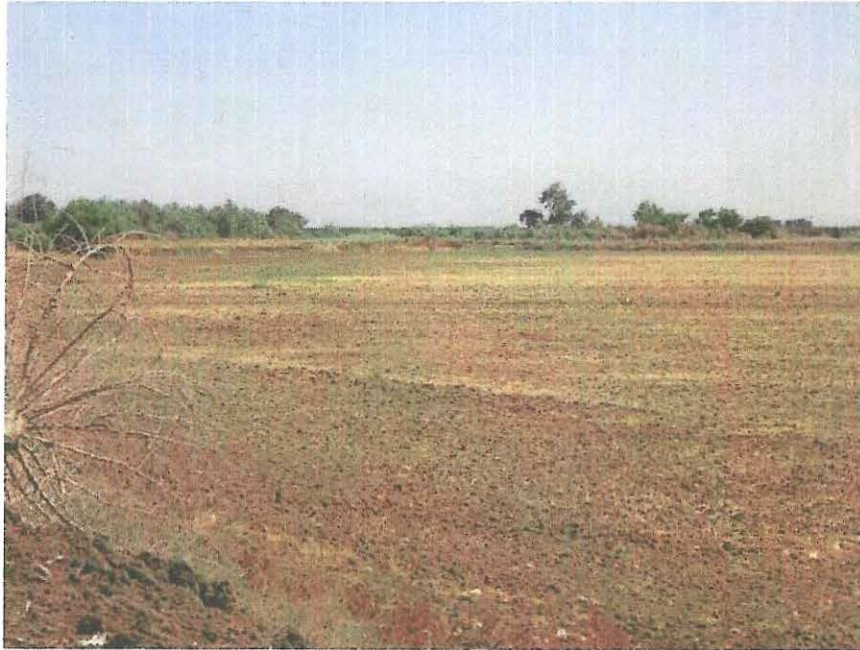
Figure 2. Fields 1 and 2, slope demonstrating elevated position of Marshall Drain in bottom left corner of image; photo from 2013 report

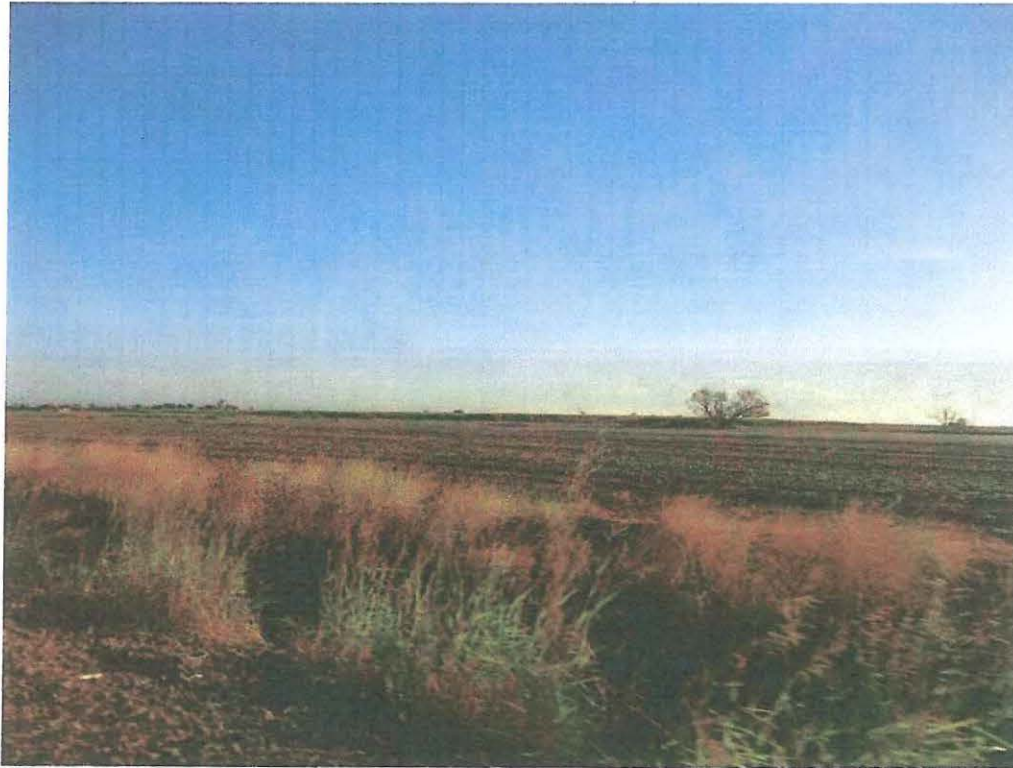
Figure 3. Fallowed field near airstrip

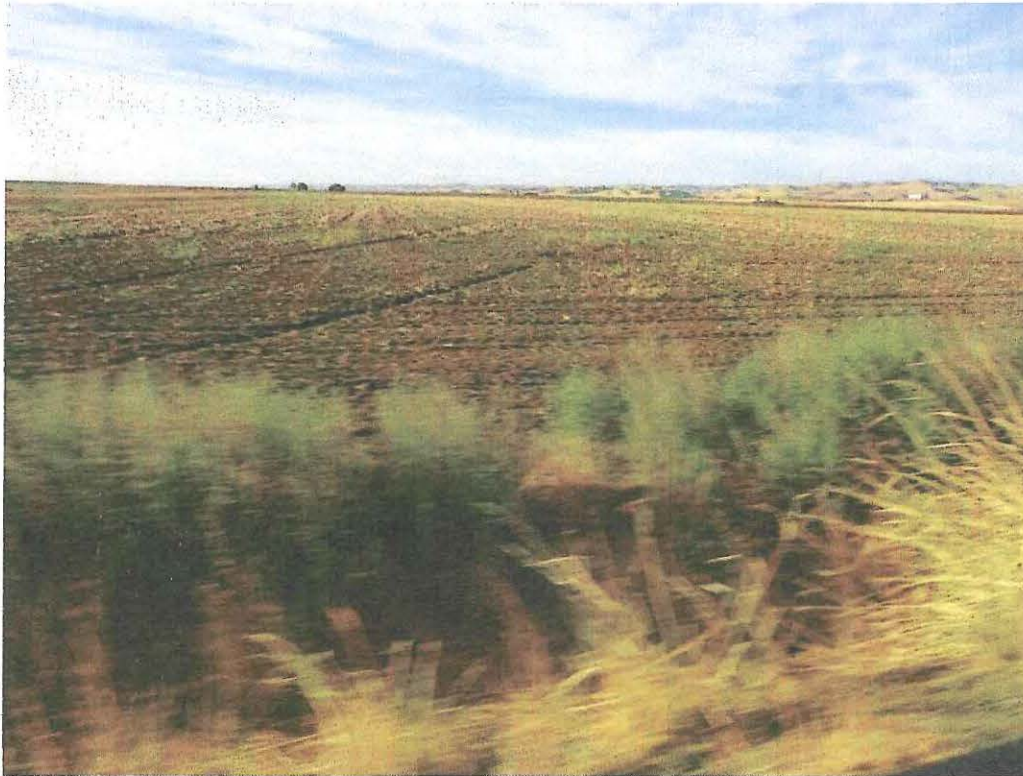
1. Airstrip
Garbage and debris no longer present on airstrip, and was thoroughly cleaned
2. Fields
The operator is responsibly managing fields, with minor weed presence on field margins (see Figure 4). Due to ongoing drought conditions and lack of water available in the area many fields were left fallowed. We did see one field (Field 10, Figure 11) that had been planted in cannery tomatoes that had recently been harvested. Minor crop residue and weeds were present in fields not currently in production.

Figure 4. Fallowed Field 8; weeds alongside

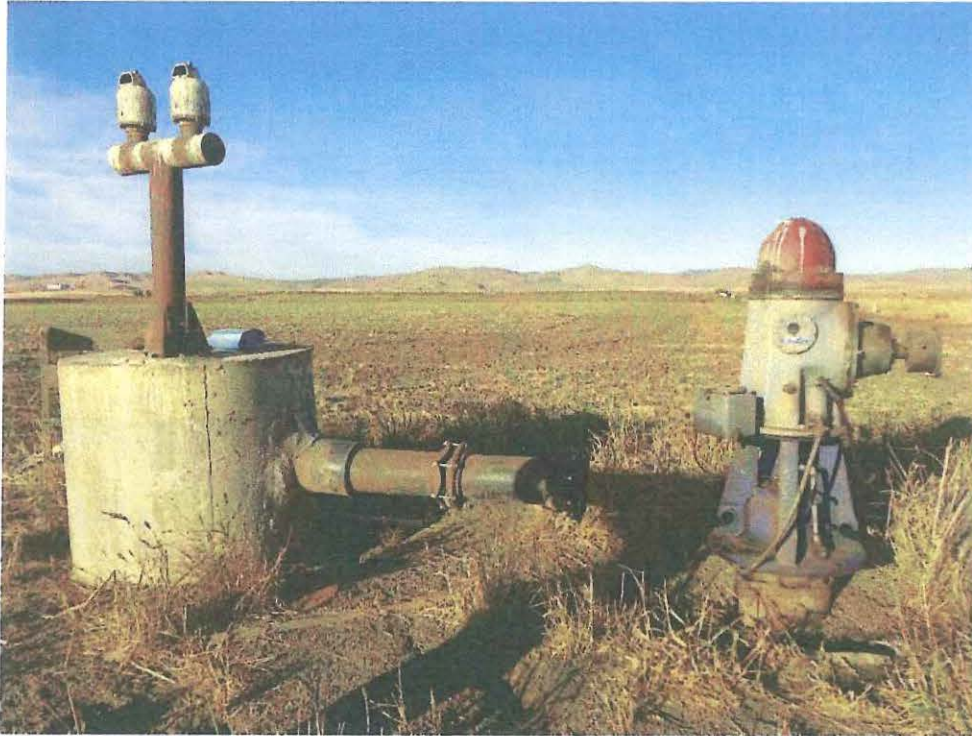
It was reported in 2013 that the potential for unwanted contaminants to enter groundwater through irrigations wells on the property was high. We are happy to report that well 6/8-20C1 has been capped and will no longer have the potential for groundwater contamination and no longer continues to provide a direct conduit to groundwater. As stated in the 2013 report, the tenant has reported to the Stanislaus County Department of Environmental Resources that he would like to rehabilitate the well and convert it to an operational system. This appears to have occurred and there is now a pump attached to the well. A stationary engine will be needed to make the well operational. The rehabilitation occurred sometime between the July 2013 and October 2014 monitoring.

Figure 7. Well 6/8-20C1 has been rehabilitated since 2013 monitoring

4. Wells
Wells are under the supervision of Stanislaus County Department of Environmental Resources. Well 6/8-20C1 has been rehabilitated and no longer continues to present an environmental risk (Figure 7). It is suggested that the county or property operator consider fencing all wells on the property to protect well areas.

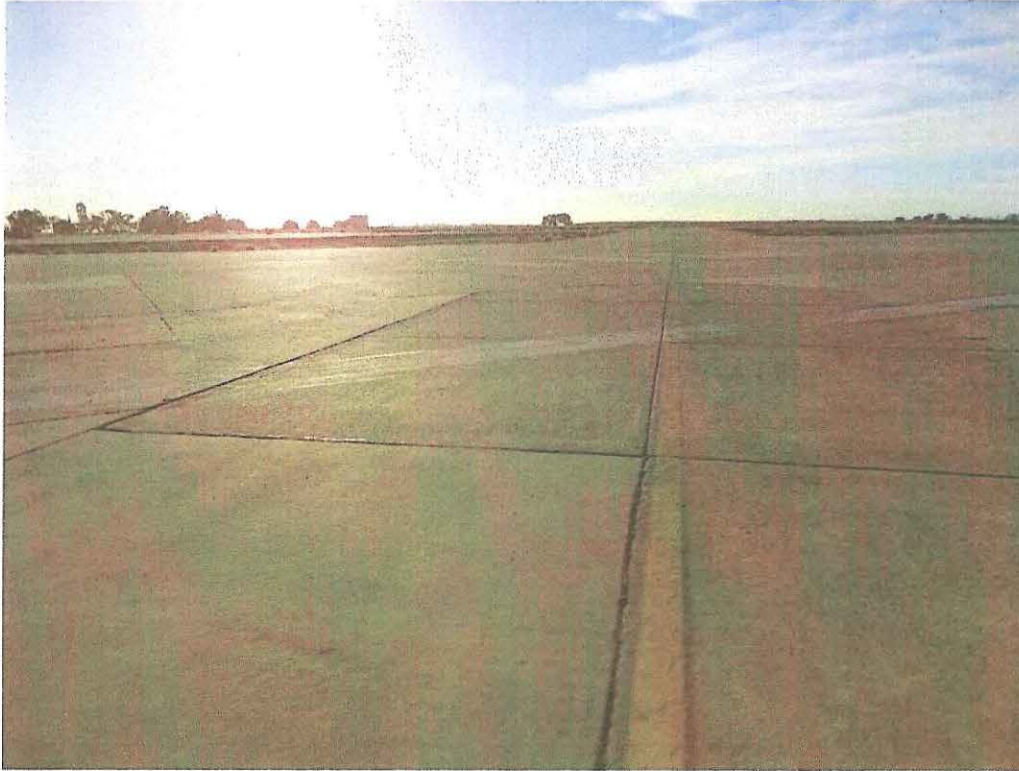
Figure 8. Airstrip

Comments/Suggestions: The property appears to have been thoroughly cleaned compared to reports from 2012 and prior. No significant trash or unused equipment was seen on the airstrip or in production areas during this monitoring tour. Weeds are present along the perimeter of the airstrip, but do not appear to be presenting a notable problem for the integrity of the airstrip.

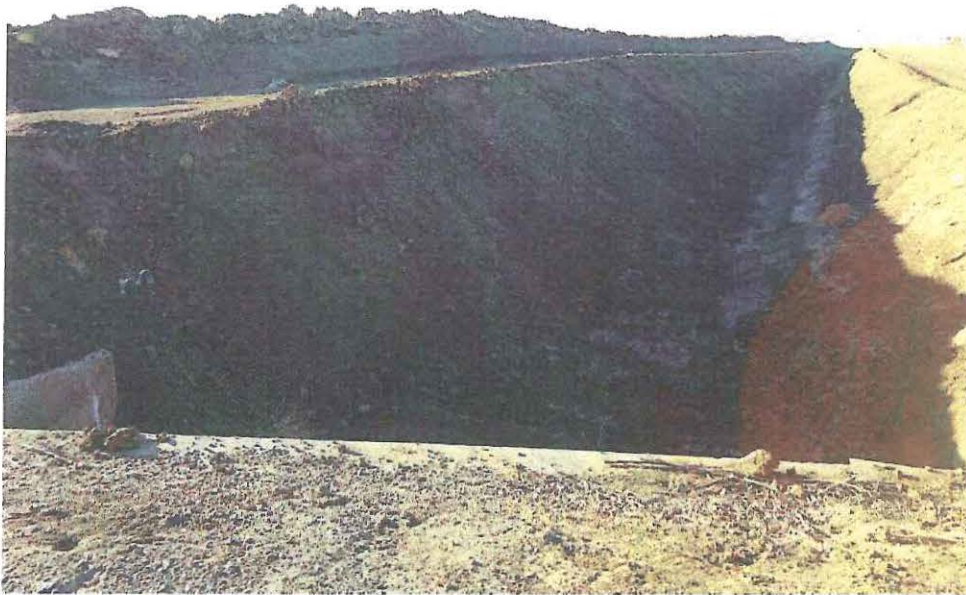
Comments/Suggestions: Little Salado Creek appears to be in good condition, and was reported to have received considerable attention since the last monitoring tour. The Boy Scout Wildlife Area was not visited during this monitoring event. It is unknown if the vegetation in the channel near the Boy Scout Wildlife Area noted in the last report might still be causing some obstruction; additionally, the actual sediment build-up in the channel is unknown by monitors. With this in mind, it is suggested that the water-holding capacity of the drain be reviewed by a party with expertise in this area, if it has not been done so already.

Figure 9. Little Salado Creek has recently been cleaned out; there is still some congestion in culvert under the road

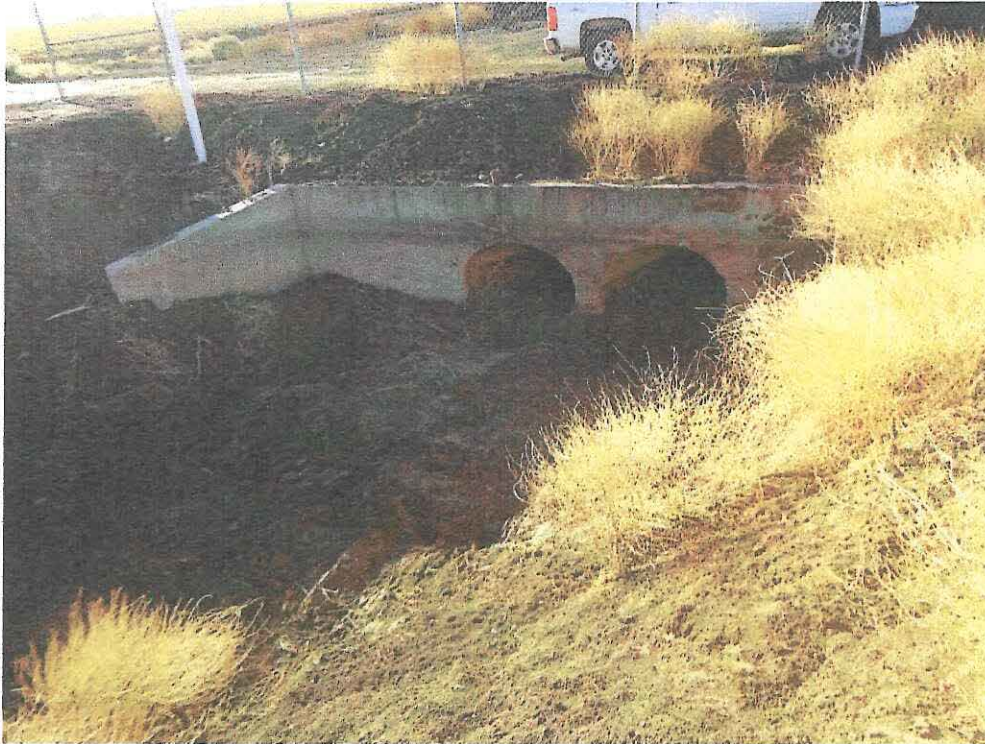
Comments/Suggestions: Irrigation water pickup ditches in and around culverts look to be in need of maintenance. Culverts viewed at the time of monitoring on the property appeared moderately congested by sediment build-up, woody debris, and weeds. It is hypothesized that these obstructions of flow could result in stream diversion through adjacent property areas during heavy irrigation events and especially during large storm events. It was verbally reported to monitors that there is a plan for improvement in these areas by the tenant in cooperation with the county. However, monitors are unaware of the details regarding this matter and did not consult the tenant on the issue, and so cannot comment further than acknowledging the current presence of sediment and weeds in the culvert.

Figure 10. Drainage culvert, moderately congested (near Airstrip); significantly cleared out since 2013 monitoring

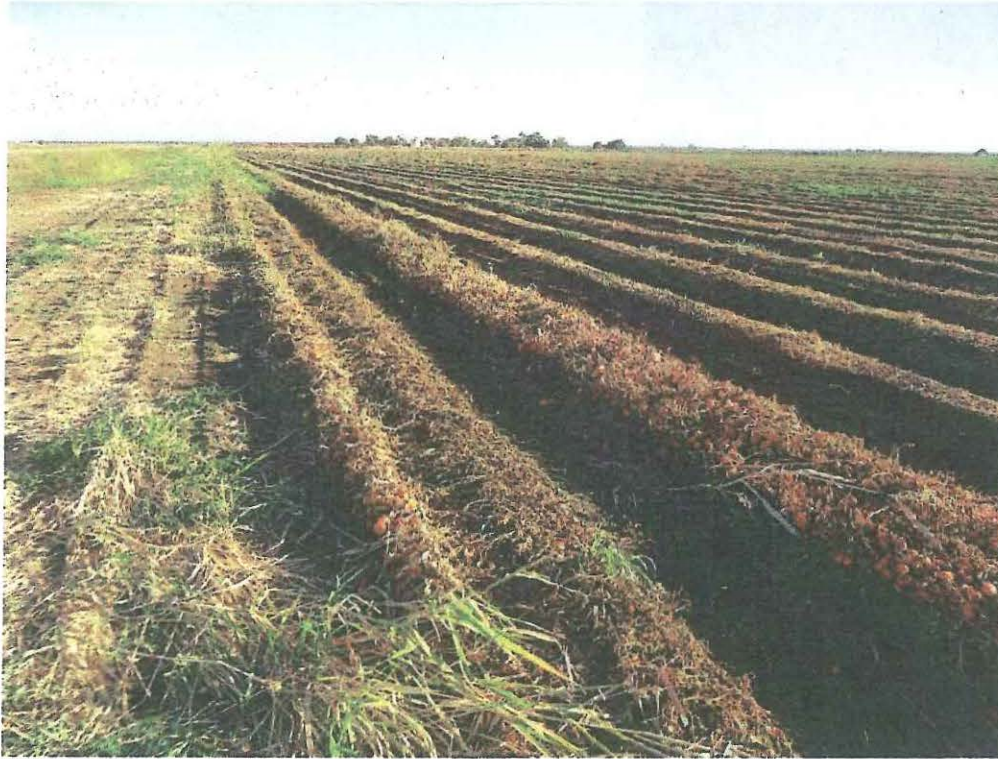
Figure 11. Field 10 production area; recently harvested tomatoes

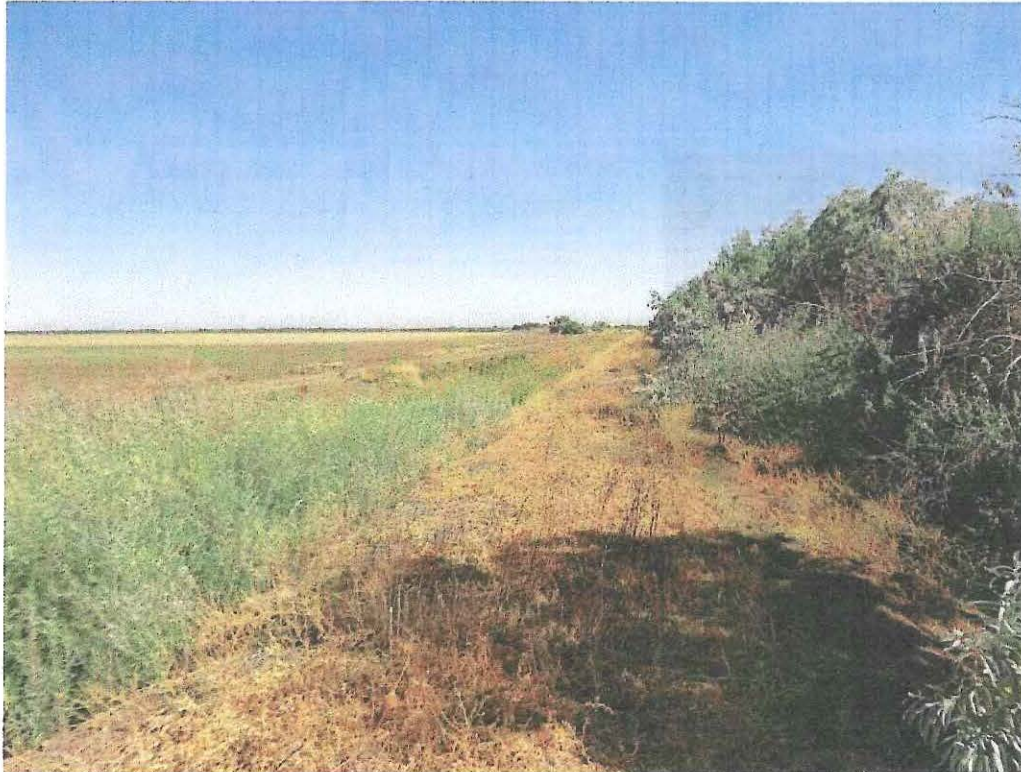
Figure 12. Marshall Drain, looking toward Marshall Road
