Crows Landing Naval Base Easement, Annual Reserve Monitoring Report 2015

West Stanislaus Resource Conservation District

June 30th, 2015

Monitoring Event Summary

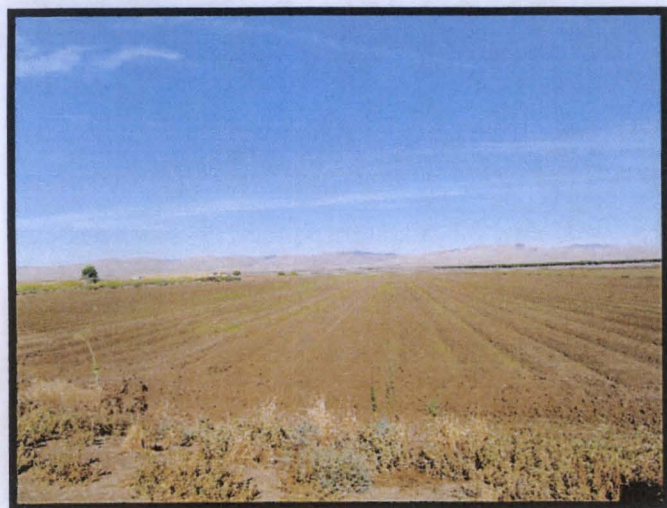
Figure 1: Field 2, recently established raised beds, potentially for processing tomatoes.

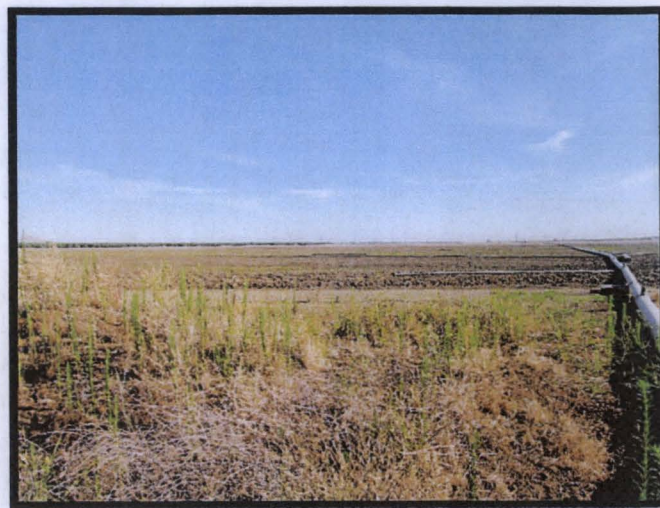
Comments and Suggestions from Monitors: Overall, the agricultural production land (roughly 1400 acres) is maintained responsibly by the grower. Fields 4 and 8 are planted currently with processing tomatoes, field 4 is extremely well maintained. Field 8 has several noxious weeds growing throughout the crop. Fields 2 and 3 had recently been tilled and have established beds, most likely for processing tomatoes. Fields 1, 2, 5, 6, 7, 9, and 10 were fallowed at this time, most likely due to the drought. Weeds are present in field borders and in drains. Eventually, all of fields will need to be leveled, borders and drains will need to be cleaned thoroughly and sediment basins will need to be dug out as well. Cumulatively, this will be a huge undertaking both in cost and time. As discussed in the 2014 Report, the elevated position of Marshall Drain on the northern end of the property suggests that, if a large storm were to occur, adjacent fields and roads (Marshall Road and Highway 33) would be flooded.

Figure 2: Field 3 production area, recently established raised beds, note the weeds in field border.

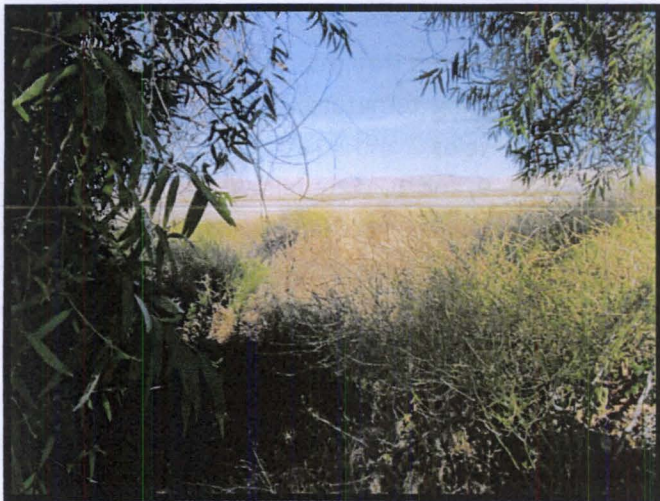
Comments and Suggestions from Monitors: The Marshall Drain is elevated around surrounding fields. In the event of a significant storm, adjacent fields and roads (Marshall Road and Highway 33) could flood, depending on severity. The channel contains large quantities of vegetation and sediment, which decreases the capacity of the drain. The monitors suggest that someone with the proper expertise clear the drain.

Figure 3: Vegetation and will trees obstructing culvert and drain.

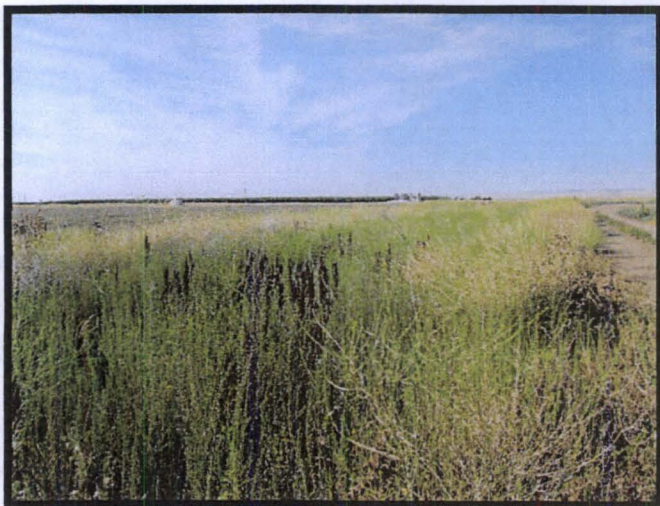
Figure 4: Marshall Drain with vegetation, looking south.

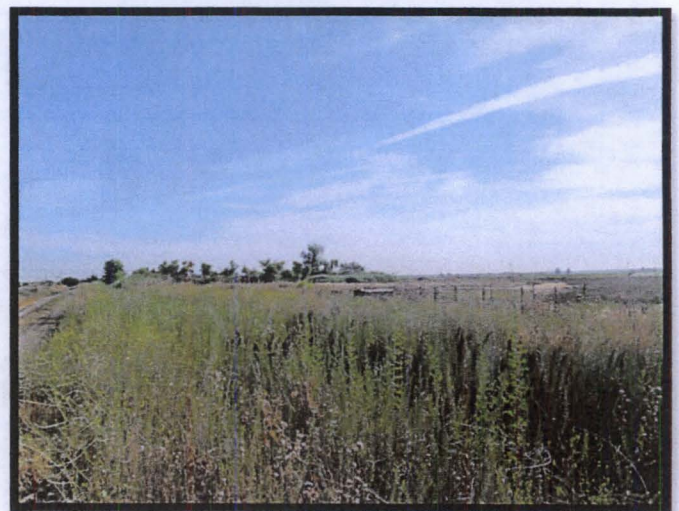
The sediment build-up and vegetation density in Little Salado Creek and Marshall Drain continue to be problems. This year with little rain or irrigation runoff, there is no water in any of the drains or creeks on the property. The Marshall Drain is elevated above surrounding fields due to increased sediment build-up. A storm event could potentially flood the drain and fields, eventually reaching Highway 33, causing a major hazard to drivers and other adjacent cropland.

Figure 5: Marshall Drain with heavy vegetation, looking north, and note slope on either side.

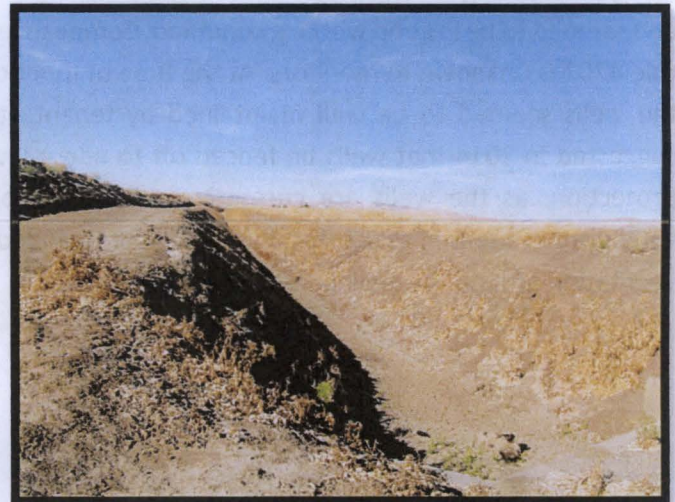
Figure 6: Little Salado Creek looking south, largely clear of all vegetation and sediment obstructions.

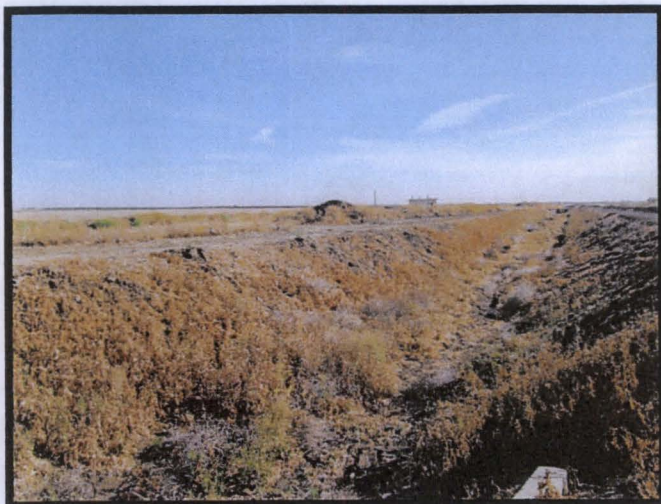
Figure 7: Little Salado Creek looking north, exhibits more weeds on this northern side.

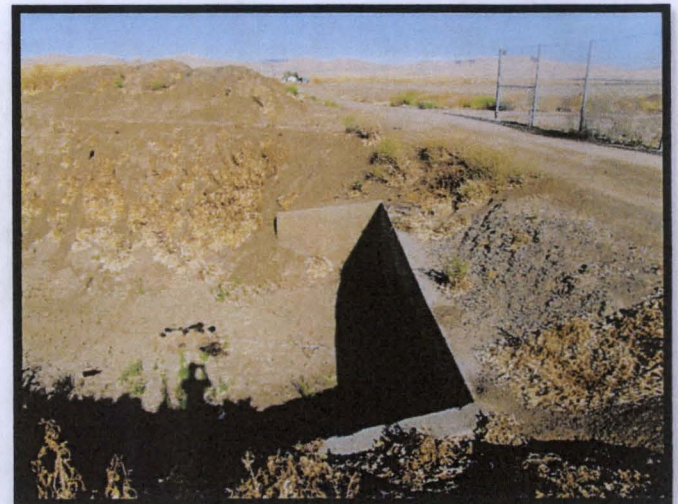
Figure 8: The culverts at Little Salado Creek, clear of obstructions.

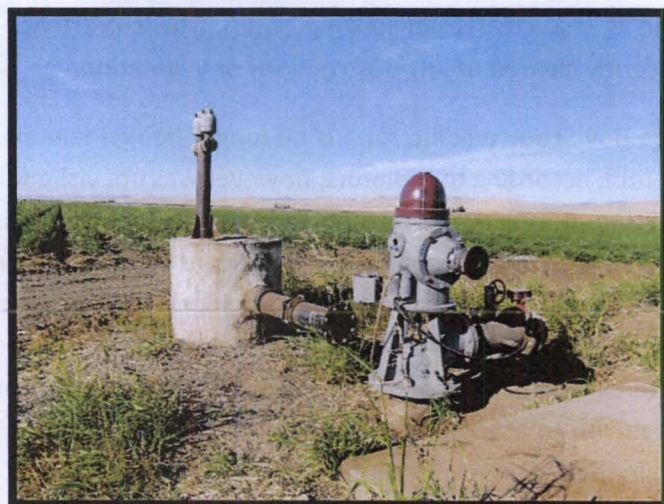
Figure 9: Well 6/8-20G is maintained well, but has no engine, thus is not in use.

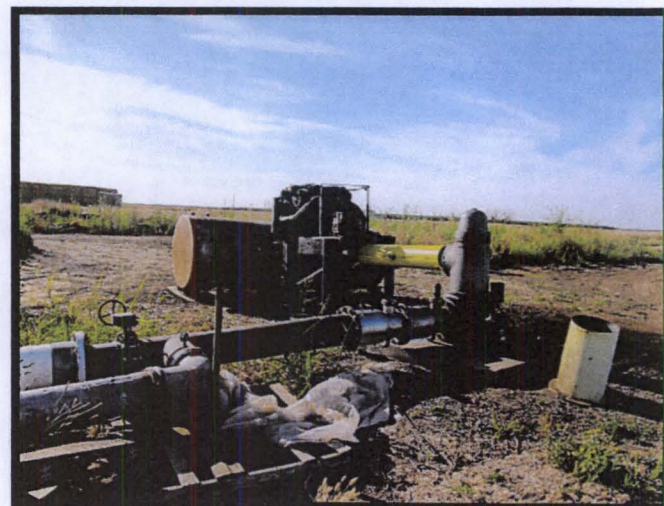
Figure 11: Well 6/8-8J is being used to irrigate fields, connected to a diesel engine.

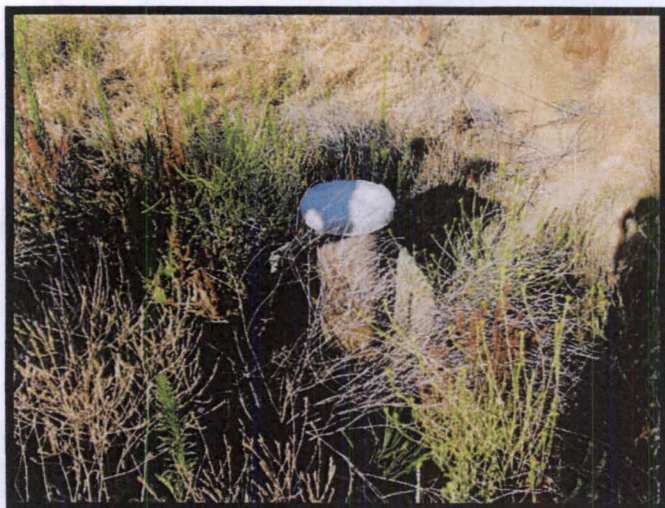
Figure 10: Well 6/8-20C1 has been properly capped and is no longer in use or a conduit for groundwater contamination.

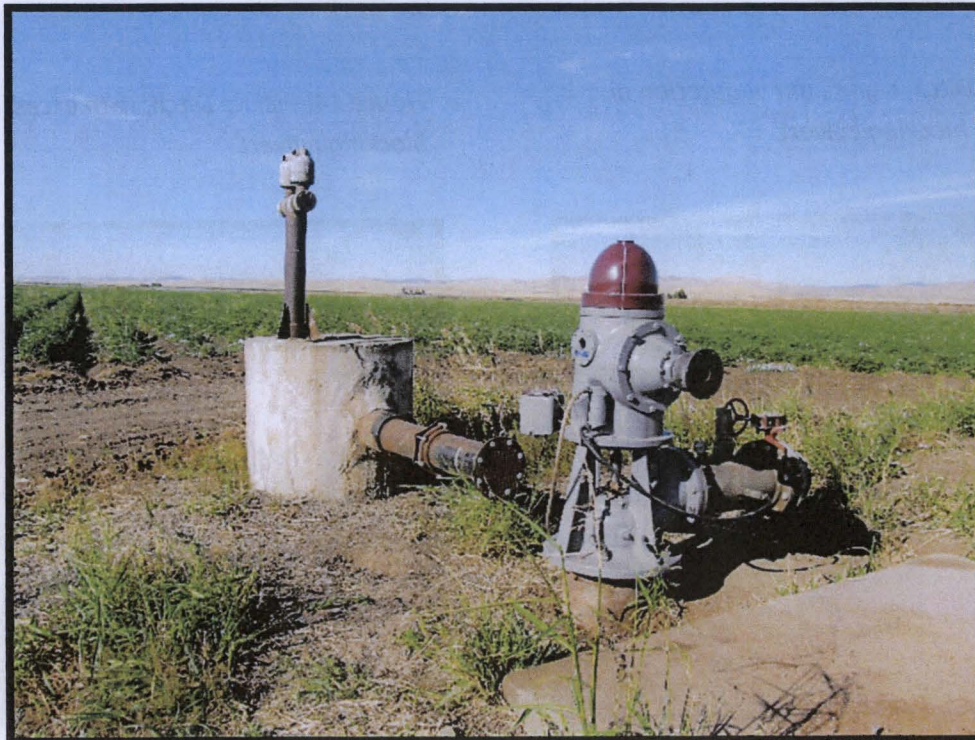
Comments and Suggestions from Monitors: Well 6/8-8J is in use at this time. No other known wells are currently in use. There are no currently known plans to put in another well. There were no noticeable construction activities that would create groundwater recharge. Well 6/8-20G is currently not operational but has a new pump. If a stationary engine was also attached, the pump could be operational. This well is in good repair and currently does not pose a threat to groundwater.

Figure 12: Well 6/8-20G has a new pump and could be operational if a diesel engine was attached.

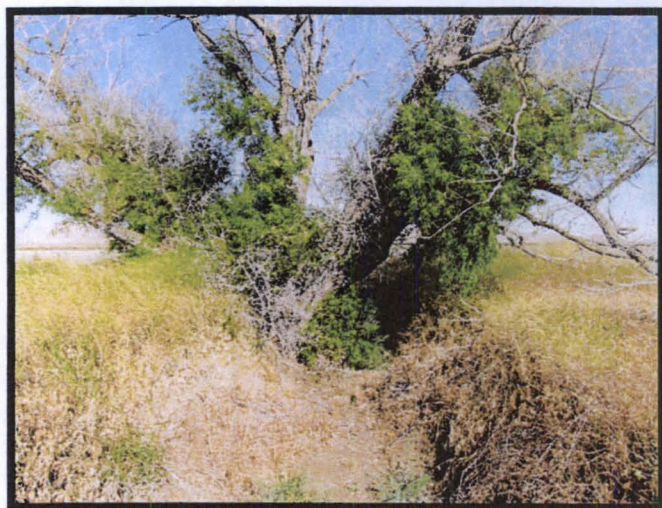
Comments and Suggestions from Monitors: Due to the drought, none of the ditches, drains, or creeks on the property had any water running through them, however it was obvious to monitors that irrigation water pickup ditches and culverts were in need of maintenance. Culverts were congested with plant material and sediment build up, which could result in stream diversion through adjacent property areas during heavy irrigation events and especially during large storm events. These drainages should be reviewed and cleared by someone with expertise in this area.

Figure 13: Pickup Ditch, significant vegetation and sediment build up blocking culvert.

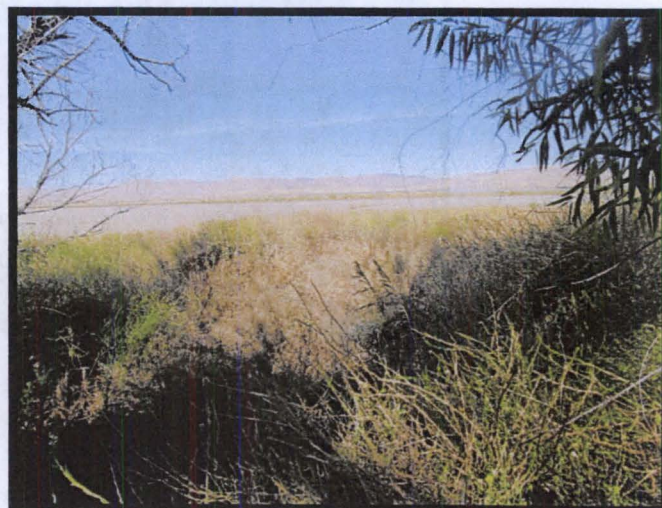
Figure 14: Pickup Ditch, with excessive vegetation blocking culvert.

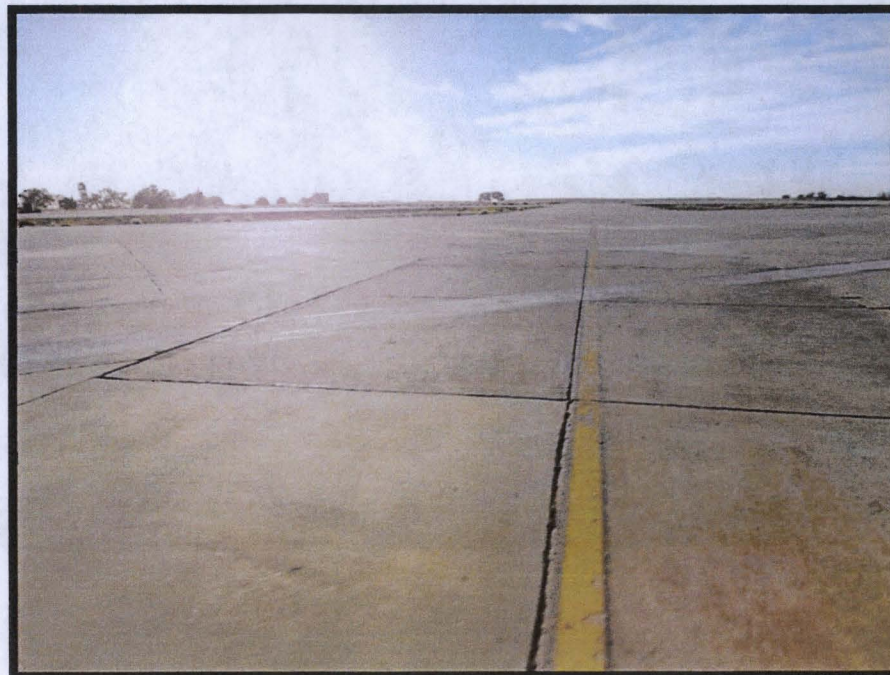
Comments and Suggestions from Monitors: The airstrip and maintenance area were in great condition. Clear of trash, debris and unused equipment, it looked like the airstrip was being well maintained. There were weeds alongside the airstrip, but the weeds should not pose a problem to the airstrip. Fences in the area seemed to be in standard condition. During the monitoring, the airstrip was being used by the Sherriff's Department for driving training. Overall, the airstrip was in good condition.

Figure 15: The airstrip, looks clean and clear of debris, trash and unused equipment.
