# CROWS LANDING NAVAL BASE EASEMENT, ANNUAL RESERVE MONITORING REPORT 2016

JULY 12<sup>TH</sup>, 2016

*Annual monitoring event conducted at the Crows Landing Naval Airstrip on the agricultural outlease by West Stanislaus Resource Conservation District Directors, Tom Maring and Ed Perry. Report prepared by Caitie Campodonico.*

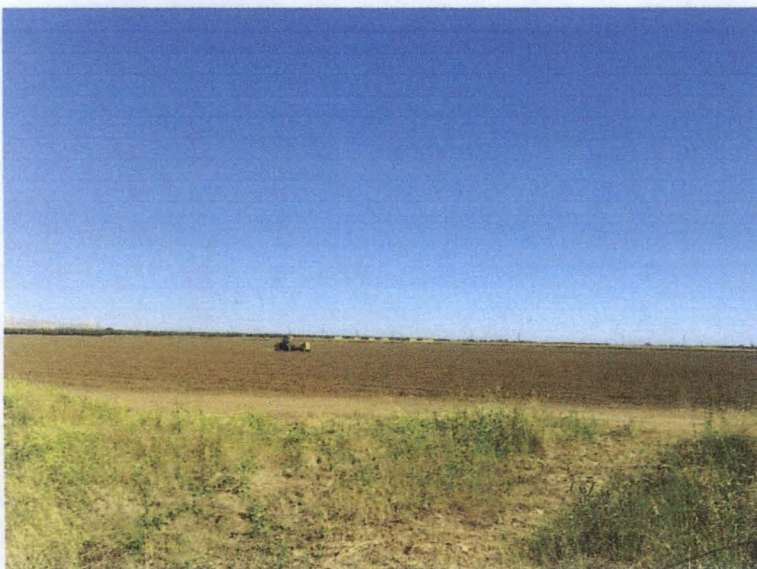
Figure 1: Production area being prepared for crop planting.

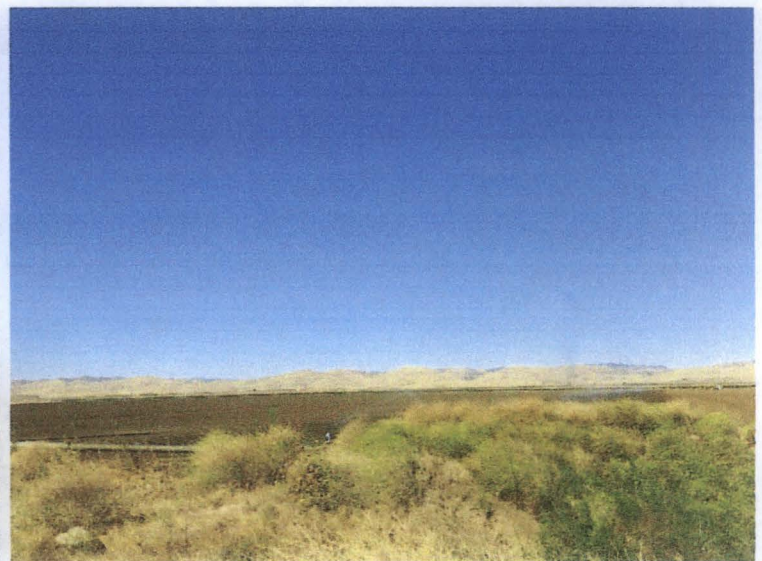
Figure 2: Field 3 being irrigated with sprinklers.

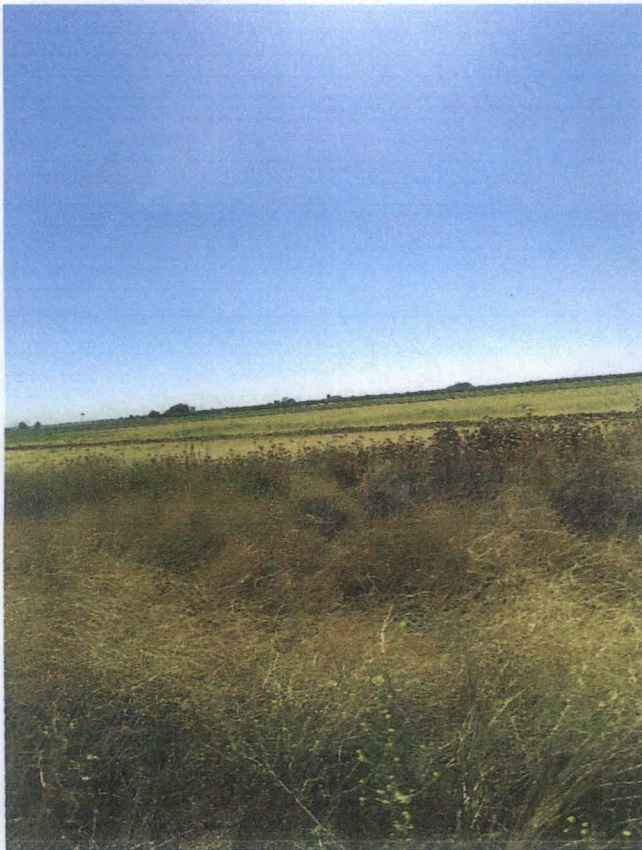
**Comments and Suggestions from Monitors:** The Marshall Drain is still significantly higher than the surrounding fields. If there were to be a significant storm, the surrounding fields and adjacent road (Marshall Road and Highway 33) could flood, depending on severity. The channel contains excessive vegetation and sediment, which does not allow the drain to work to full capability. The monitors suggest that someone with the proper expertise come inspect and clear the drain to ensure that it is functional again.

Figure 3: Elevated position of Marshall Drain taken from road.

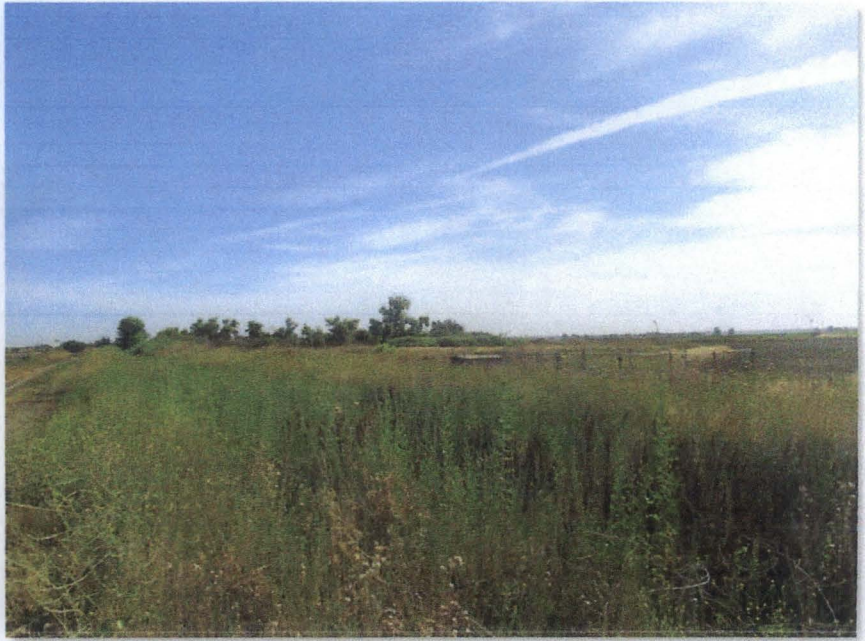
Figure 4: Looking down the center of Marshall Drain, fields on either side are lower and center is filled with vegetation.

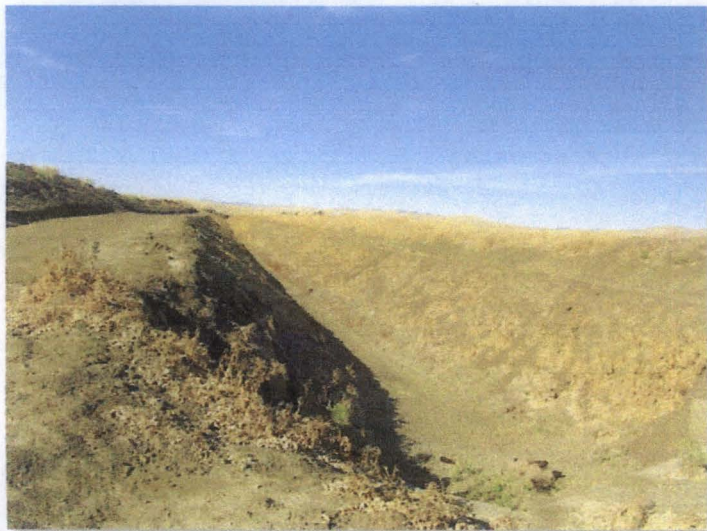
Figure 5 (below): Little Salado Creek is cleared of vegetation.

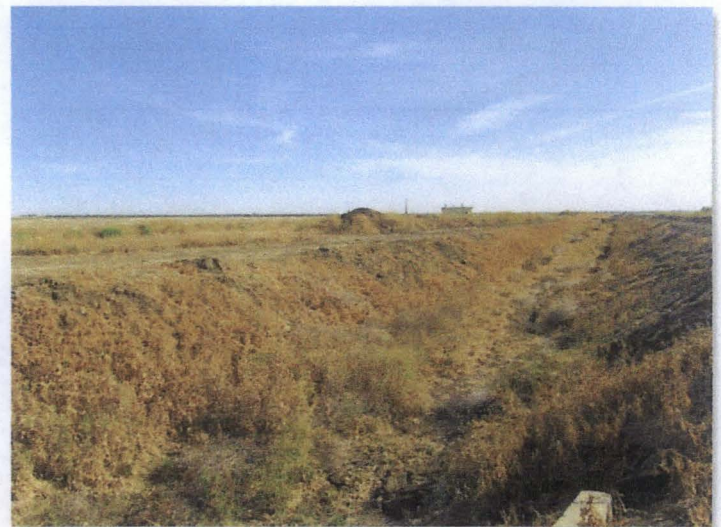
Figure 6 (above): Little Salado Creek, looking north, still has some vegetation but does not cause an issue. Little Salado Creek has no water running through it.

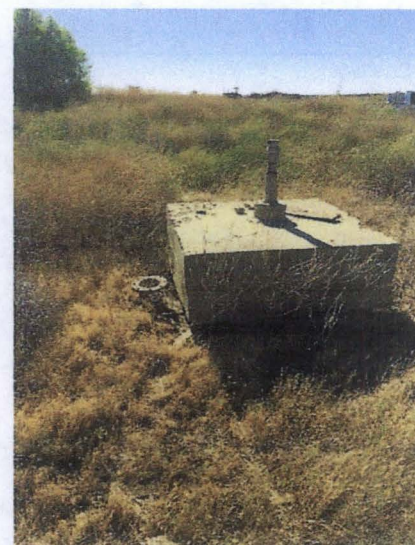
Figure 7 (right): Well 6/8-20C1 is capped and no threat to groundwater.

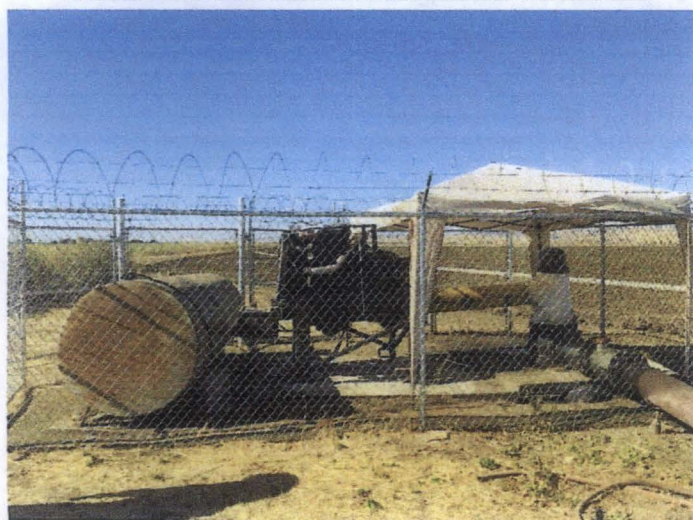
Figure 8 (below): Newly fenced in well 6/8-8J, well maintained.

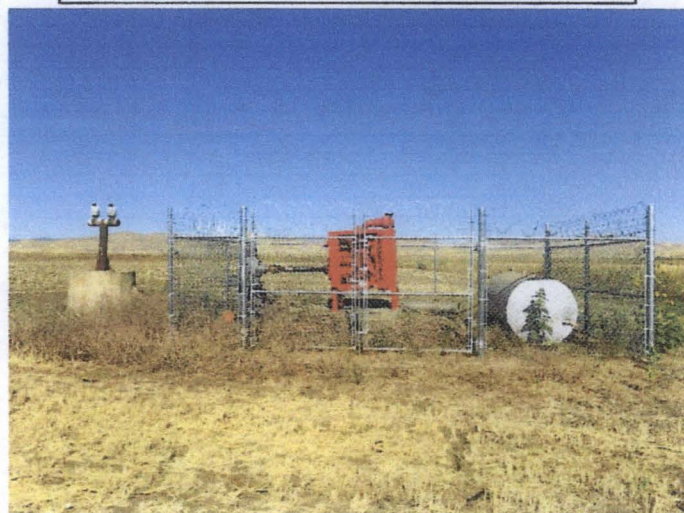
Figure 9 (below): Well 6/8-20G is newly fenced and has a new motor connected.

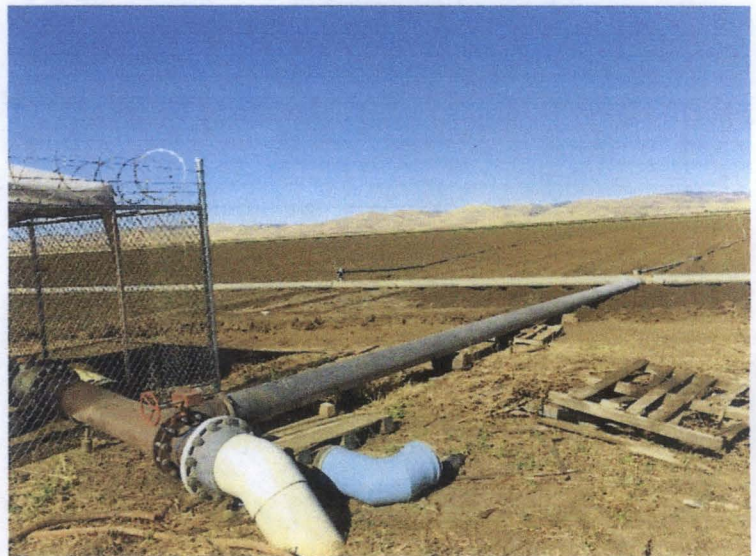
Figure 10 (right): Existing well with new fencing around it, irrigating (sprinkler) agricultural production field.

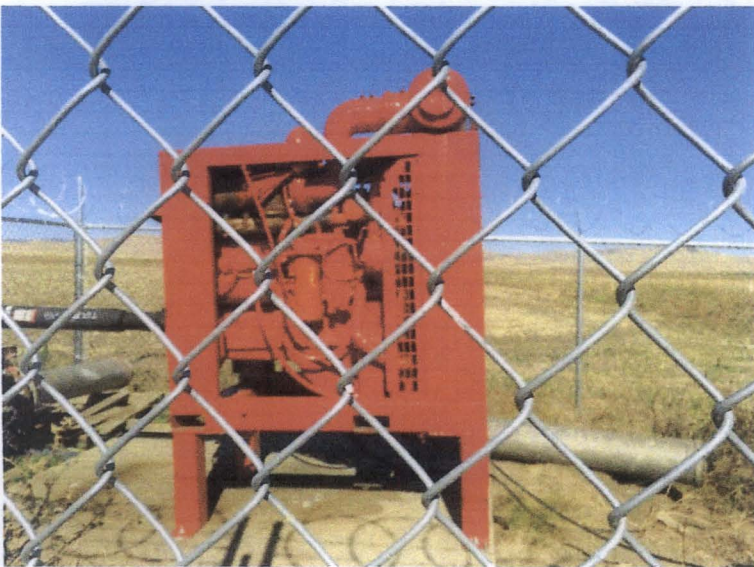
Figure 11 (left); New motor placed on existing well to make it operational. This well was also fenced in this year to cut down on vandalism.

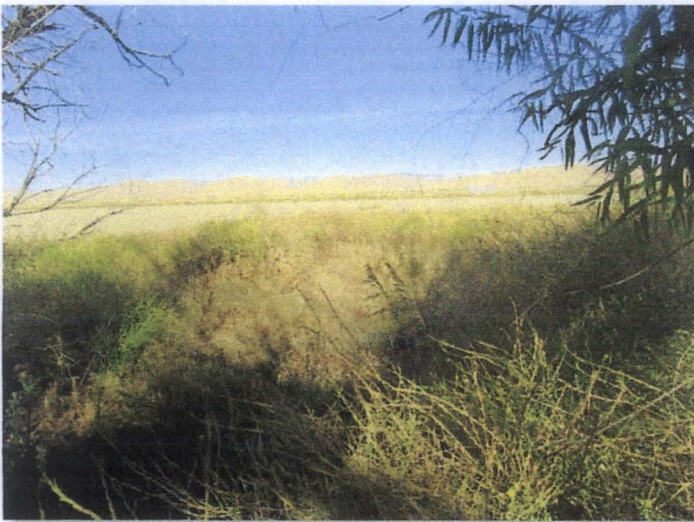
**Comments and Suggestions from Monitors:** Due to the drought, none of the ditches, drains, or creeks on the property had any water running through them, however it was obvious to monitors that irrigation water pickup ditches and culverts were in need of maintenance. Culverts were congested with plant material and sediment build up, which could result in stream diversion through adjacent property areas during heavy irrigation events and especially during large storm events. These drainages should be reviewed and cleared by someone with expertise in this area.

Figure 12 (left): Pickup drain looking over fields that is full of vegetation.

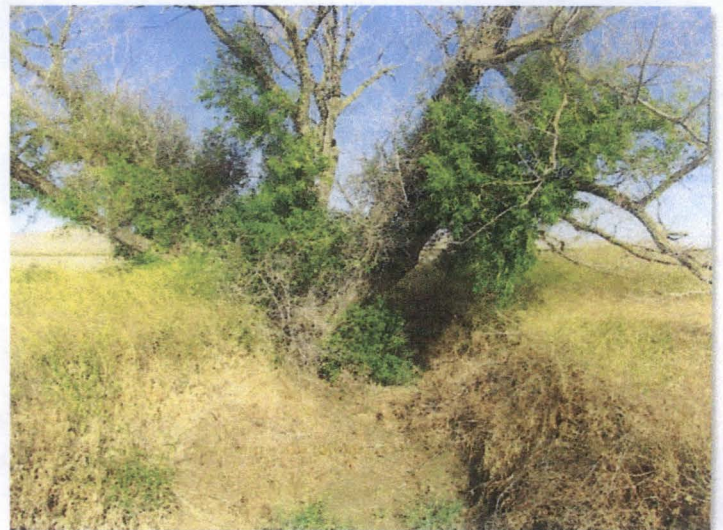
Figure 13: Large willow tree that is obstructing the culvert. No water present in the ditch.

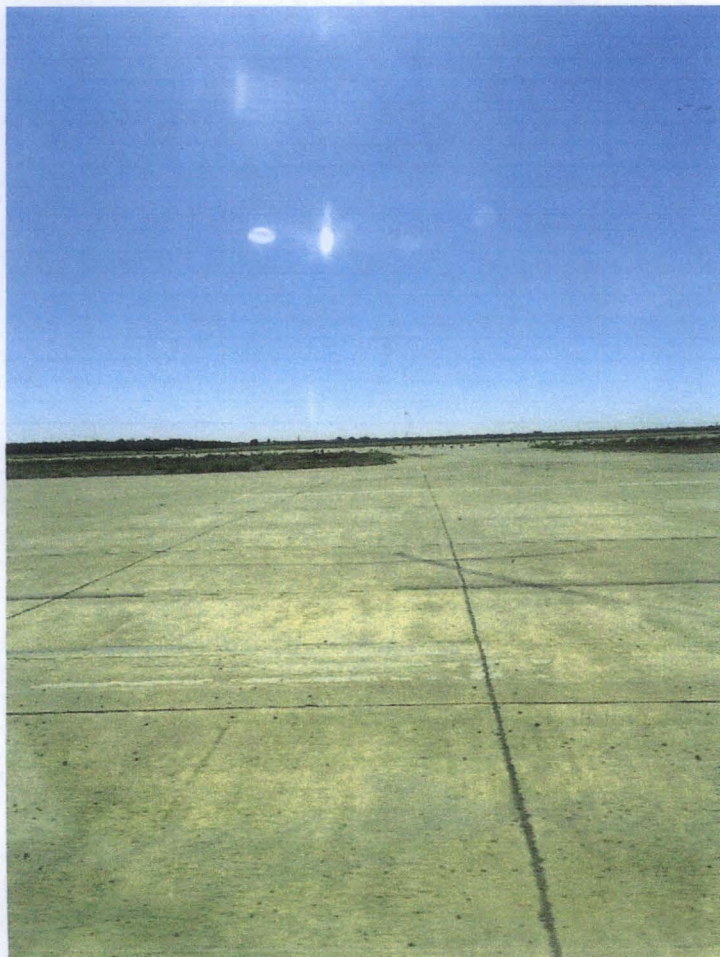
Figure 14: The runway is clear. Cones in the back of the photo are being used to designate a course for driving training done by Sheriff's Department.
