CROWS LANDING NAVAL BASE EASEMENT, ANNUAL RESERVE MONITORING REPORT 2017

AUGUST 7TH, 2017

Annual monitoring event conducted at the Crows Landing Naval Airstrip on the agricultural outlease by West Stanislaus Resource Conservation District Director, Tom Maring. Report prepared by Caitie Campodonico.

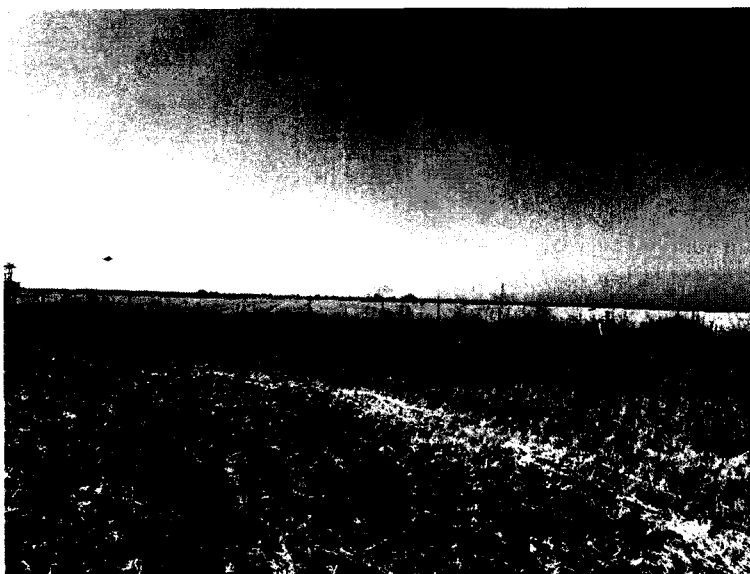
Comments and Suggestions from Monitors: Overall, the agricultural production land (roughly 1400 acres) is maintained responsibly by the grower. No fields were in production during the monitoring event in August. There was an employee of the leasee out checking fields during our monitoring event. He was working on clearing a blocked drain. Weeds are present in field borders and in drains.

Figure 1: Weeds present around empty fields.

Eventually, as reported previously, all fields should be leveled. Field borders and drains should be thoroughly cleaned and sediment basins dug out. Cumulatively, this will be a large and expensive undertaking. The elevated position of the Marshall Drain continues to be a concern as it could flood all of the fields and surrounding fields in the event of a large storm.

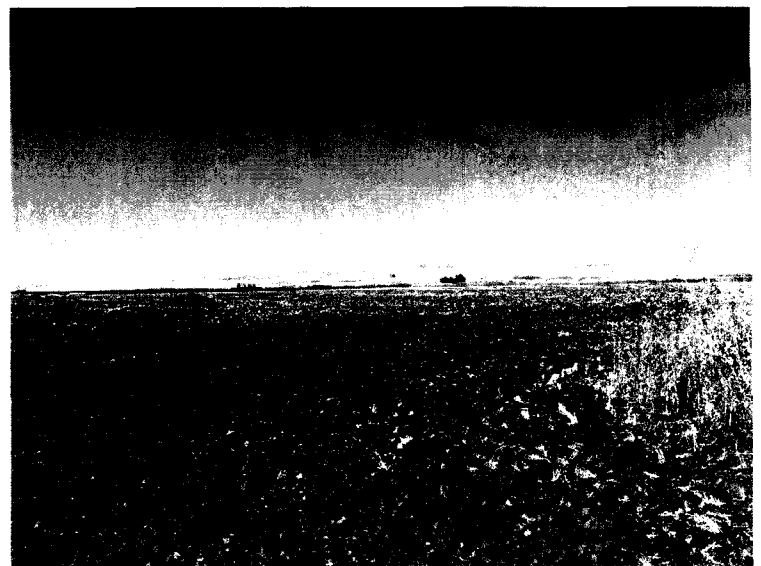
Figure 2: Empty production field

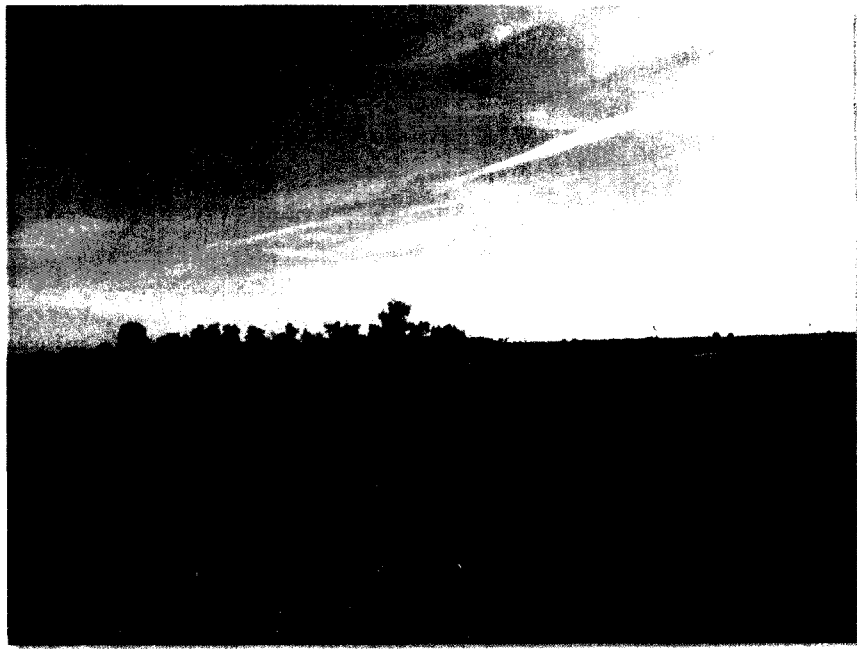
Figure 4: Looking down the center of Marshall Drain, fields on either side are lower and center is filled with vegetation.

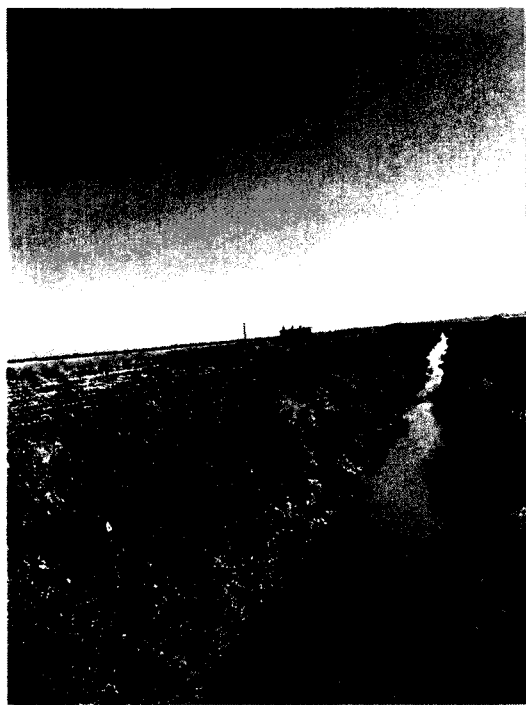
Figure 6 (above): Little Salado Creek, looking north, still has some vegetation but does not cause an issue.

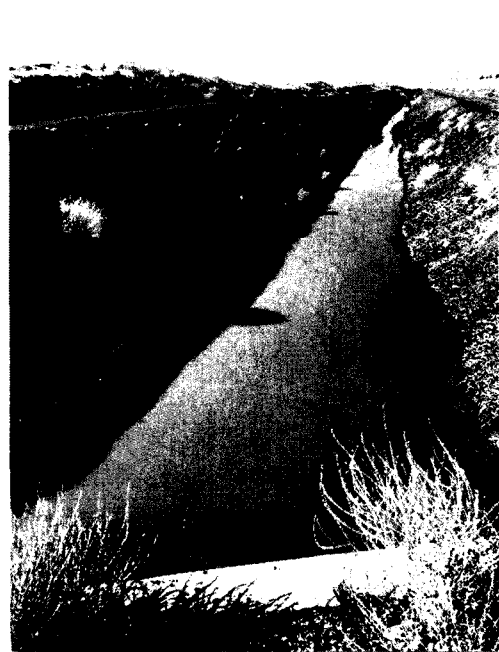
Comments and Suggestions from Monitors: Little Salado Creek is largely clear of vegetation, obstructions, sediment and trash. Little Salado Creek looking north has more vegetation and is less clear than looking south. The culvert was cleaned out in the last two years and is free from any obstructions and vegetation.

Figure 5 (below): Little Salado Creek is cleared of vegetation.

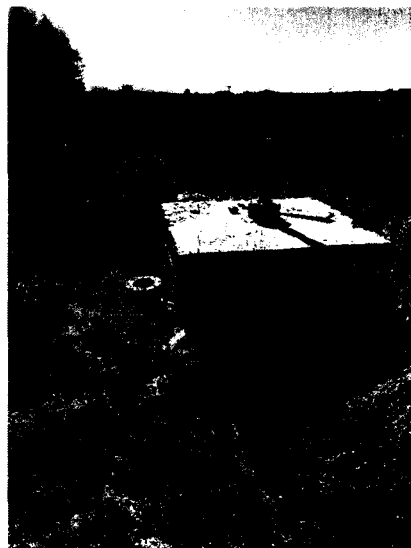
Figure 7 (right): Well 6/8-20C1 is capped and no threat to groundwater.

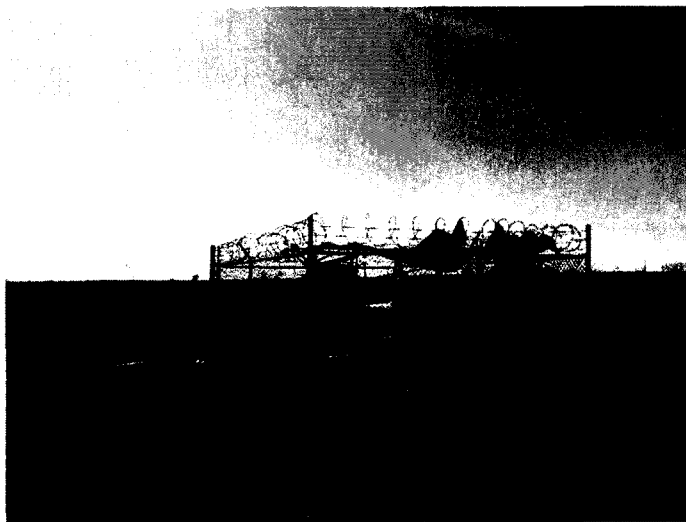
Figure 8 (below): Newly fenced in well 6/8-8J, well maintained, but has weeds present.

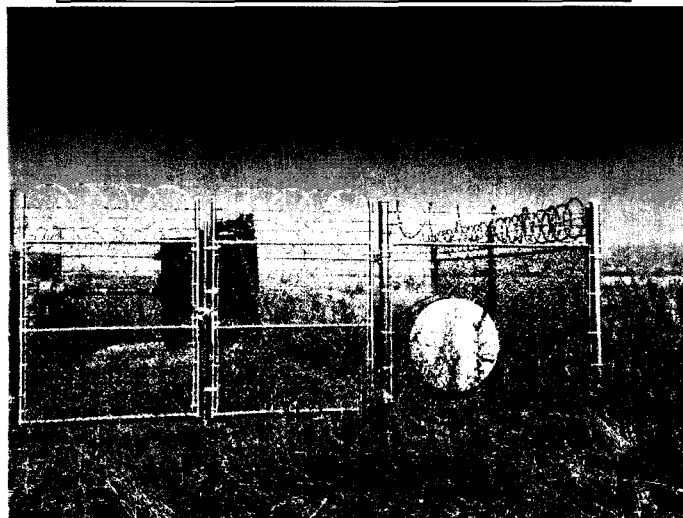
Figure 9 (below): Well 6/8-20G is newly fenced and has a new motor connected.

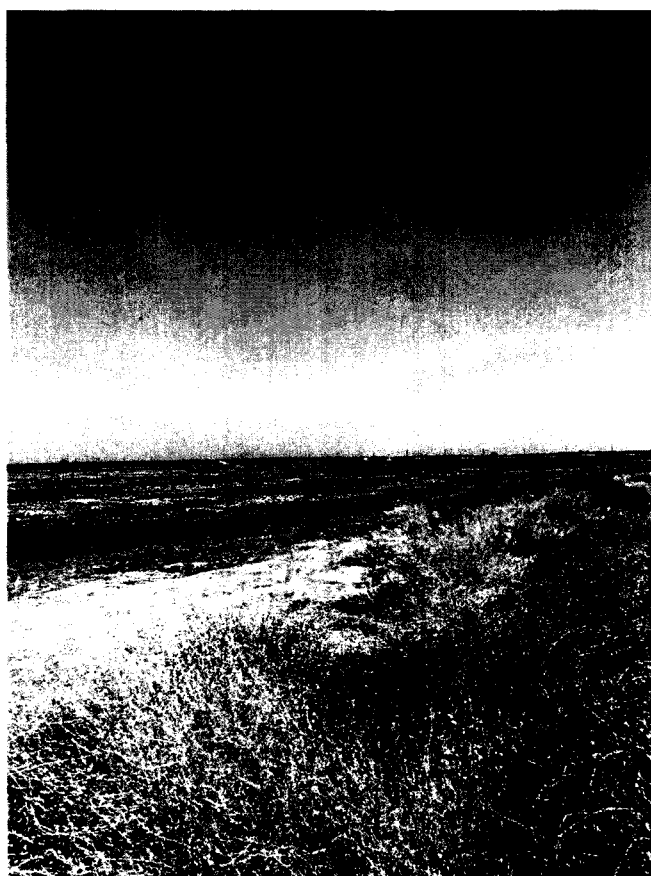
Figure 10 (right): Empty field with water present.

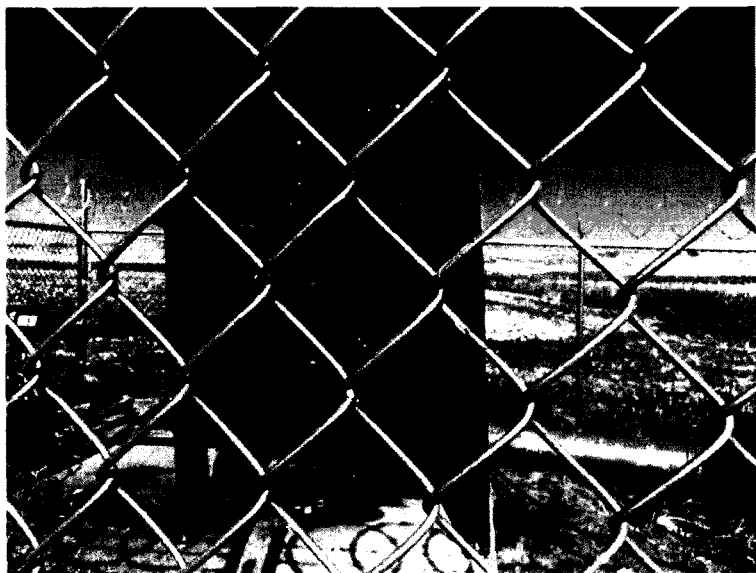
Figure 11 (left): New motor placed on existing well to make it operational. This well was also fenced in this year to cut down on vandalism.

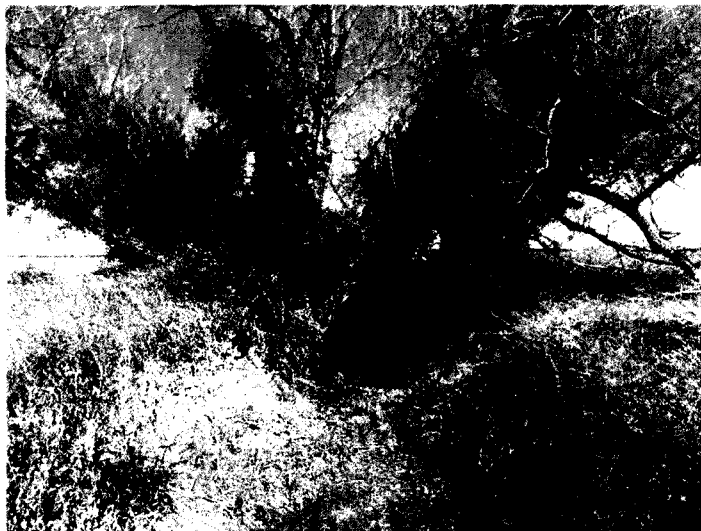
Comments and Suggestions from Monitors: This year, Little Salado Creek had water moving through it for the first time in a long time. Some of the smaller ditches had some water present. It was obvious to monitors that irrigation water pickup ditches and culverts were in need of maintenance. Culverts were congested with plant material and sediment build up, which could result in stream diversion through adjacent property areas during heavy irrigation events and especially during large storm events. These drainages should be reviewed and cleared by someone with expertise in this area.

Figure 13: Large willow tree that is obstructing the culvert. No water present in the ditch.

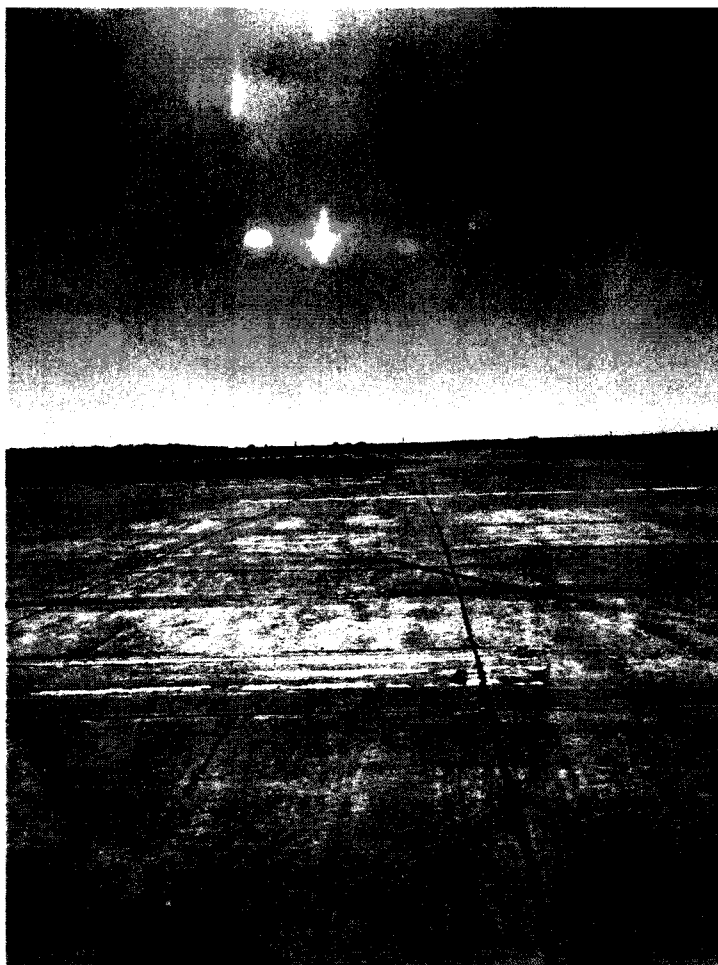
Comments and Suggestions from Monitors: The airstrip and maintenance area were in great condition. Clear of trash, debris and unused equipment, it looked like the airstrip was being well maintained. There were weeds alongside the airstrip, but the weeds should not pose a problem to the airstrip. Fences in the area seemed to be in standard condition.. Overall, the airstrip was in good condition.

Figure 14: The runway is clear.
