The West Stanislaus Resource Conservation District (WSRCD) board is proud to provide you with the 2018 Annual Monitoring Report of Natural Resources of the Crows Landing Naval Out lease Property. A copy of the report was sent to Supervisor Jim DeMartini, and Keith Boggs, Assistant Executive Officer Economic Development.

JULY 11^{TH} , 2018

Annual monitoring event conducted at the Crows Landing Naval Airstrip on the agricultural outlease by West Stanislaus Resource Conservation District Director, Tom Maring. Report prepared by Caitie Campodonico.

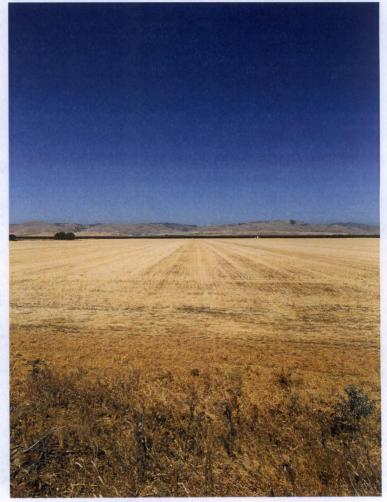
responsibly by the grower. No fields were in production during the monitoring event in June, but had been used to grow hay in the winter of 2018. Weeds are present in field borders and in drains.

Figure 1: Weeds present around empty clean fields.

Eventually, as reported previously, all fields should be leveled. Field borders and drains should be thoroughly cleaned and sediment basins dug out. Cumulatively, this will be a large and expensive undertaking. The elevated position of the Marshall Drain continues to be a concern as it could flood all of the fields and surrounding fields in the event of a large storm.

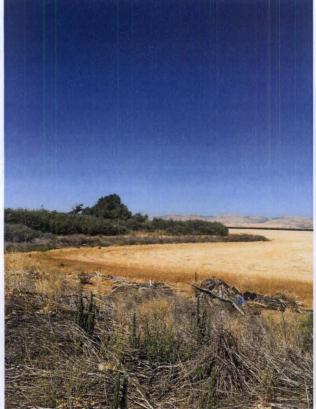
Comments and Suggestions from Monitors: The Marshall Drain is still significantly higher than the surrounding fields. If there were to be a significant storm, the surrounding fields and adjacent road (Marshall Road and Highway 33) could flood, depending on severity. The channel contains excessive vegetation and sediment, which does not allow the drain to work to full capability. The monitors suggest that someone with the proper expertise come inspect and clear the drain to ensure that it is functional again.

Figure 2: Weeds around the edge of field and roadway, looking into the overgrown Marshall Drain

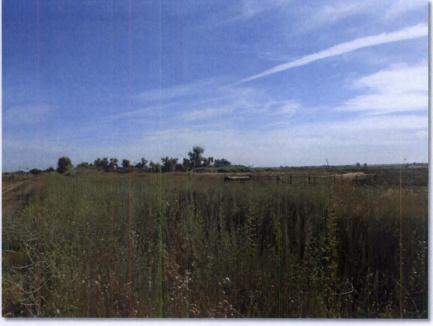
Figure 3: Looking down the center of Marshall Drain, fields on either side are lower and center is filled with vegetation.

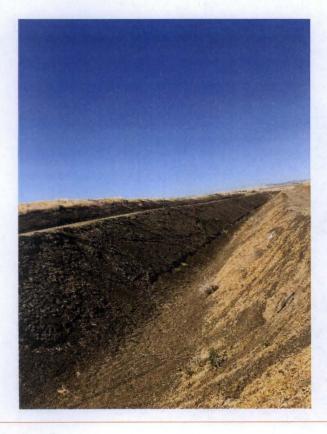
Comments and Suggestions from Monitors: Little Salado Creek is largely clear of vegetation, obstructions, sediment and trash. Little Salado Creek had no running water in it during the monitoring. The culvert was cleaned out in the last two years and is free from any obstructions and vegetation.

Figure 4 (left): Clean and dry Little Salado Creek. Figure 5 (right): Little Salado Creek Bank with Fenced Bridge.

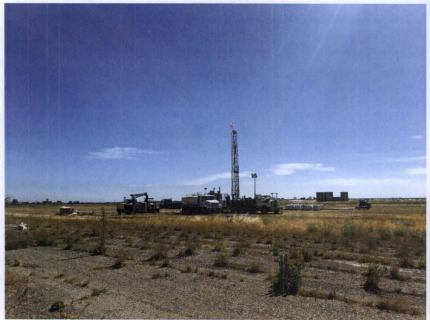
Figure 6 (below): Well Drilling Equipment by the runway.

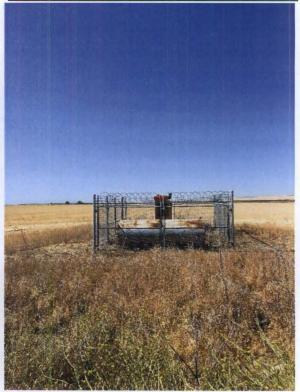
Comments and Suggestions from Monitors: Two wells are in working order in 2018. Well 6/8-8J has been operational for the past several years. This year there were no crops planted and the motor was not running. A new stationary engine was added to well 6/8-20G in 2016, which made it operational. Well 6/8-20C1 was capped and is no longer a potential conduit for groundwater contamination. The two diesel engines on the operational wells seem to be in good working condition. Compliance with rule 4702 is unknown to monitors. At the time of monitoring, all wells seemed to be well maintained by the tenant. Wells were in good condition and followed the Best Management Practices outline in water quality guides. The new test wells were observed but not monitored closely as they were not operational wells and were being used by the county to check water availability for potential development in the future.

Figure 7 (below): Well 6/8-20G is newly fenced and has a new motor connected.

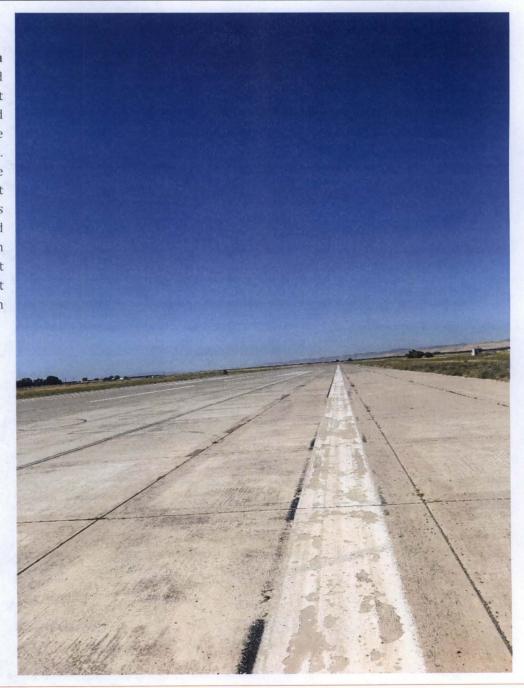
Comments and Suggestions from **Monitors:** The airstrip maintenance area were in great condition. Clear of trash, debris and unused equipment, it looked like the airstrip was being well maintained. There were weeds alongside the airstrip, but the weeds should not pose a problem to the airstrip. Fences in the area seemed to be in standard condition. Overall, the airstrip was in good condition. It was great to see first responders and law enforcement using the airstrip for training again this year.

Figure 12: The runway is clear and clean.
