THE BOARD OF SUPERVISORS OF THE COUNTY OF STANISLAUS  
ACTION AGENDA SUMMARY

Approval to Negotiate and Execute an Agreement with the Modesto Regional Fire Authority for the Modesto Firefighter Training Symposium at the Honor Farm located at 8224 West Grayson Road, Modesto, California 95358

## ASBESTOS SAMPLING REPORT

### **LEAD HAZARD EVALUATION REPORT**

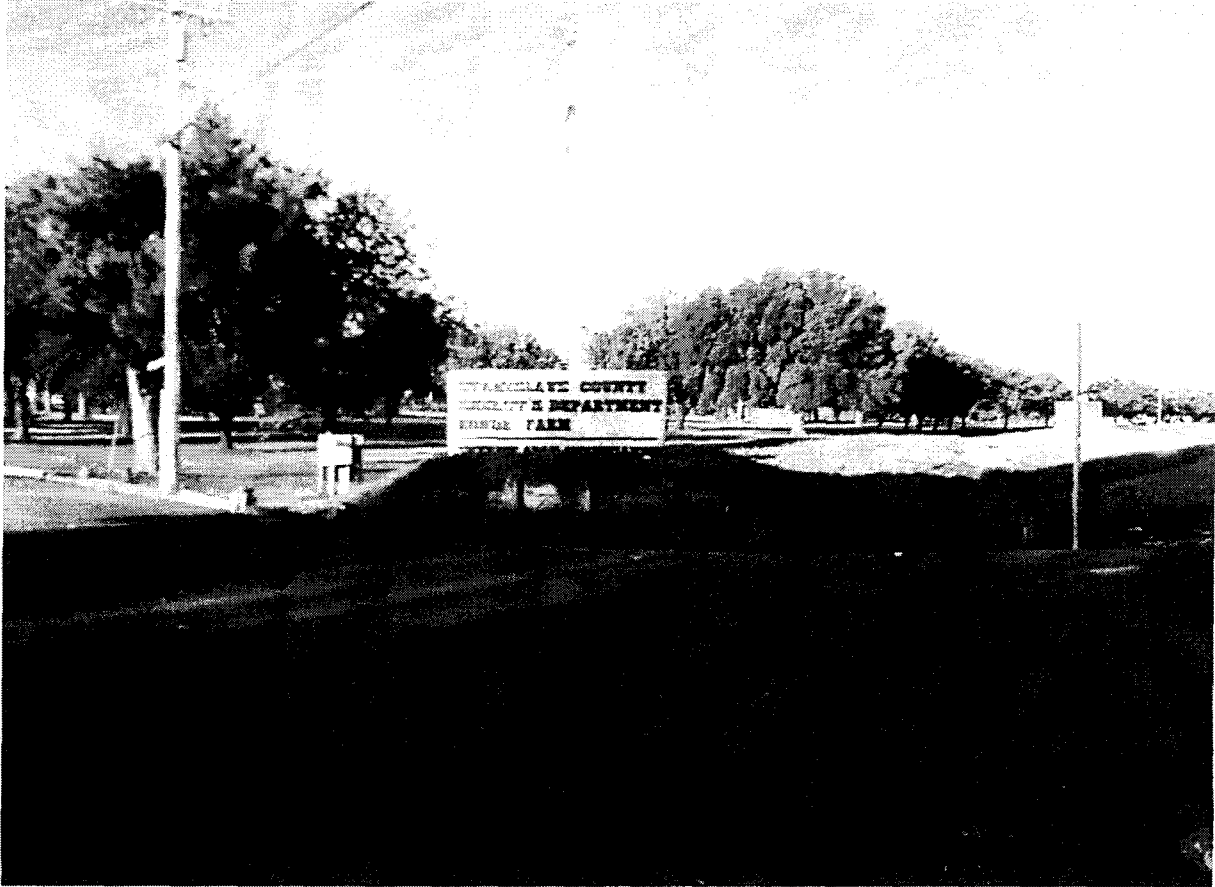
Destructive Training:  
Flow water, attach props  
to walls

Destructive Training:  
Flow water, Breach  
walls, construct props  
for destruction

4. Authority shall remove all of its materials and clean up and restore the Facility site to a reasonable condition following the Symposium, with the exception of those areas depicted on the site plan attached hereto as Exhibit "B" as undergoing "Destructive Training."
