Approval to Purchase Four Surplus Buildings from the Stanislaus County Office of Education for Use by Behavioral Health and Recovery Services

ASBESTOS & LEAD PAINT
INSPECTION REPORT

BEM PROJECT NO. 14-16219

Commercial
1905 Memorial Drive
Ceres, CA 95307

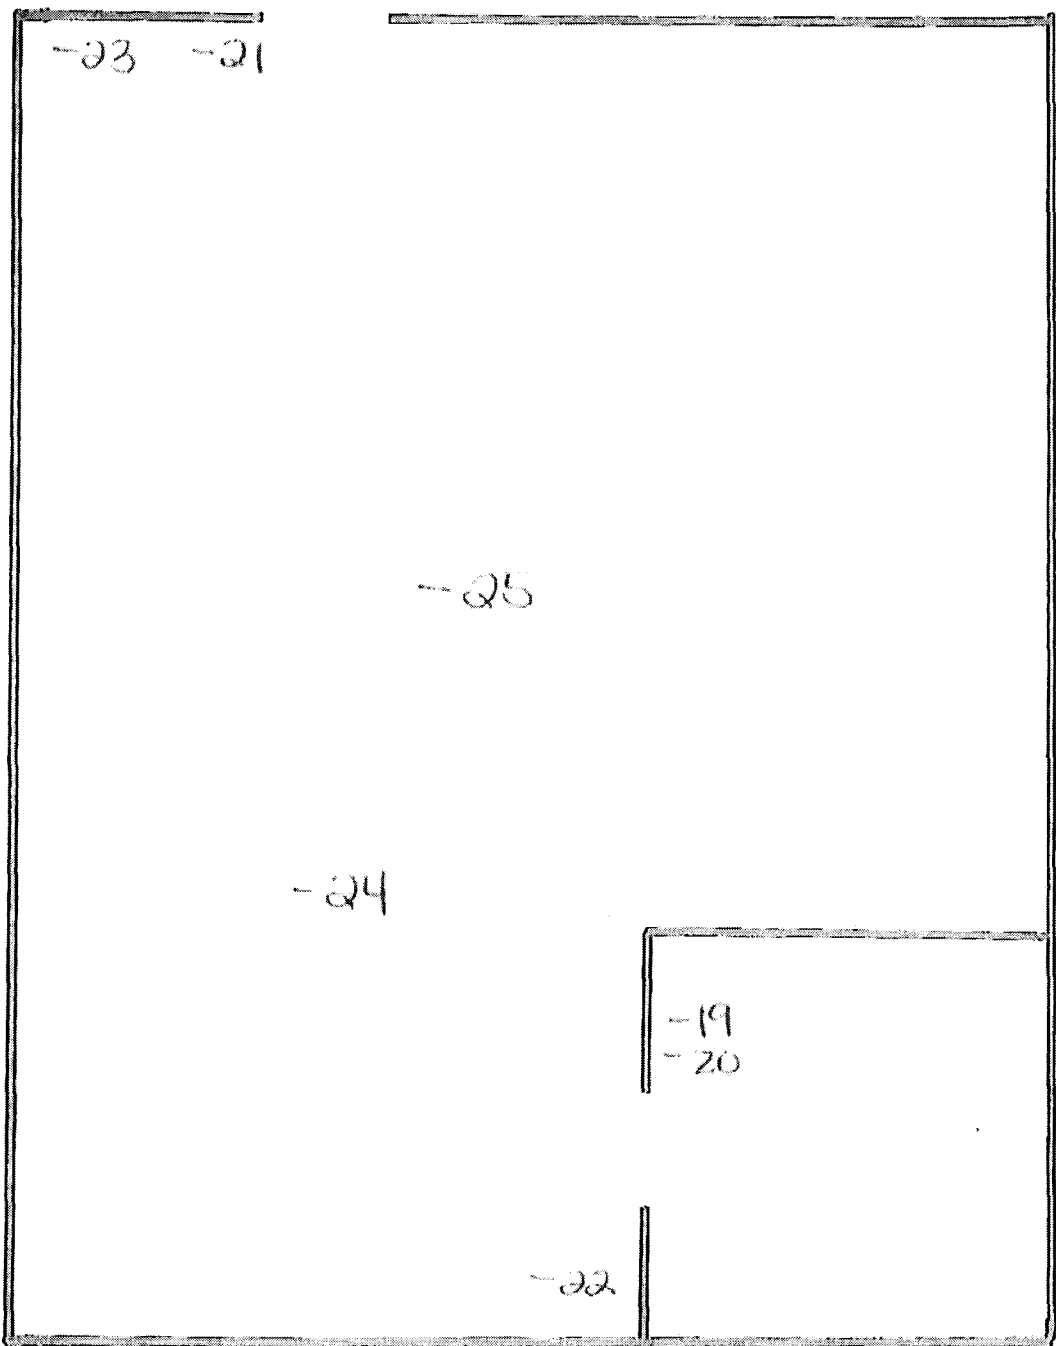
Portable #4

Commercial; 1905 Memorial Drive, Ceres, CA 95307 (Portable #4)

#	MATERIAL SAMPLED	MATERIAL LOCATION	ASBESTOS	CATEGORY	SQ. FT.
16219-19	Linoleum	Bathroom; Floor	None Detected	-	-
16219-20	Linoleum Mastic	Bathroom; Floor	None Detected	-	-
16219-21	Carpet Mastic	Floors Throughout	None Detected	-	-
16219-22	Cove Base Mastic	Baseboards Throughout	None Detected	-	-
16219-23	Panel Board	Walls Throughout	None Detected	-	-
16219-24	2' x 4' Ceiling Panel	Ceilings Throughout	None Detected	-	-
