***Hickman Road over the Tuolumne River Bridge
Replacement Project***

Natural Environment Study

Hickman Road over the Tuolumne River Bridge (38C0004)
Replacement Project

December 2016

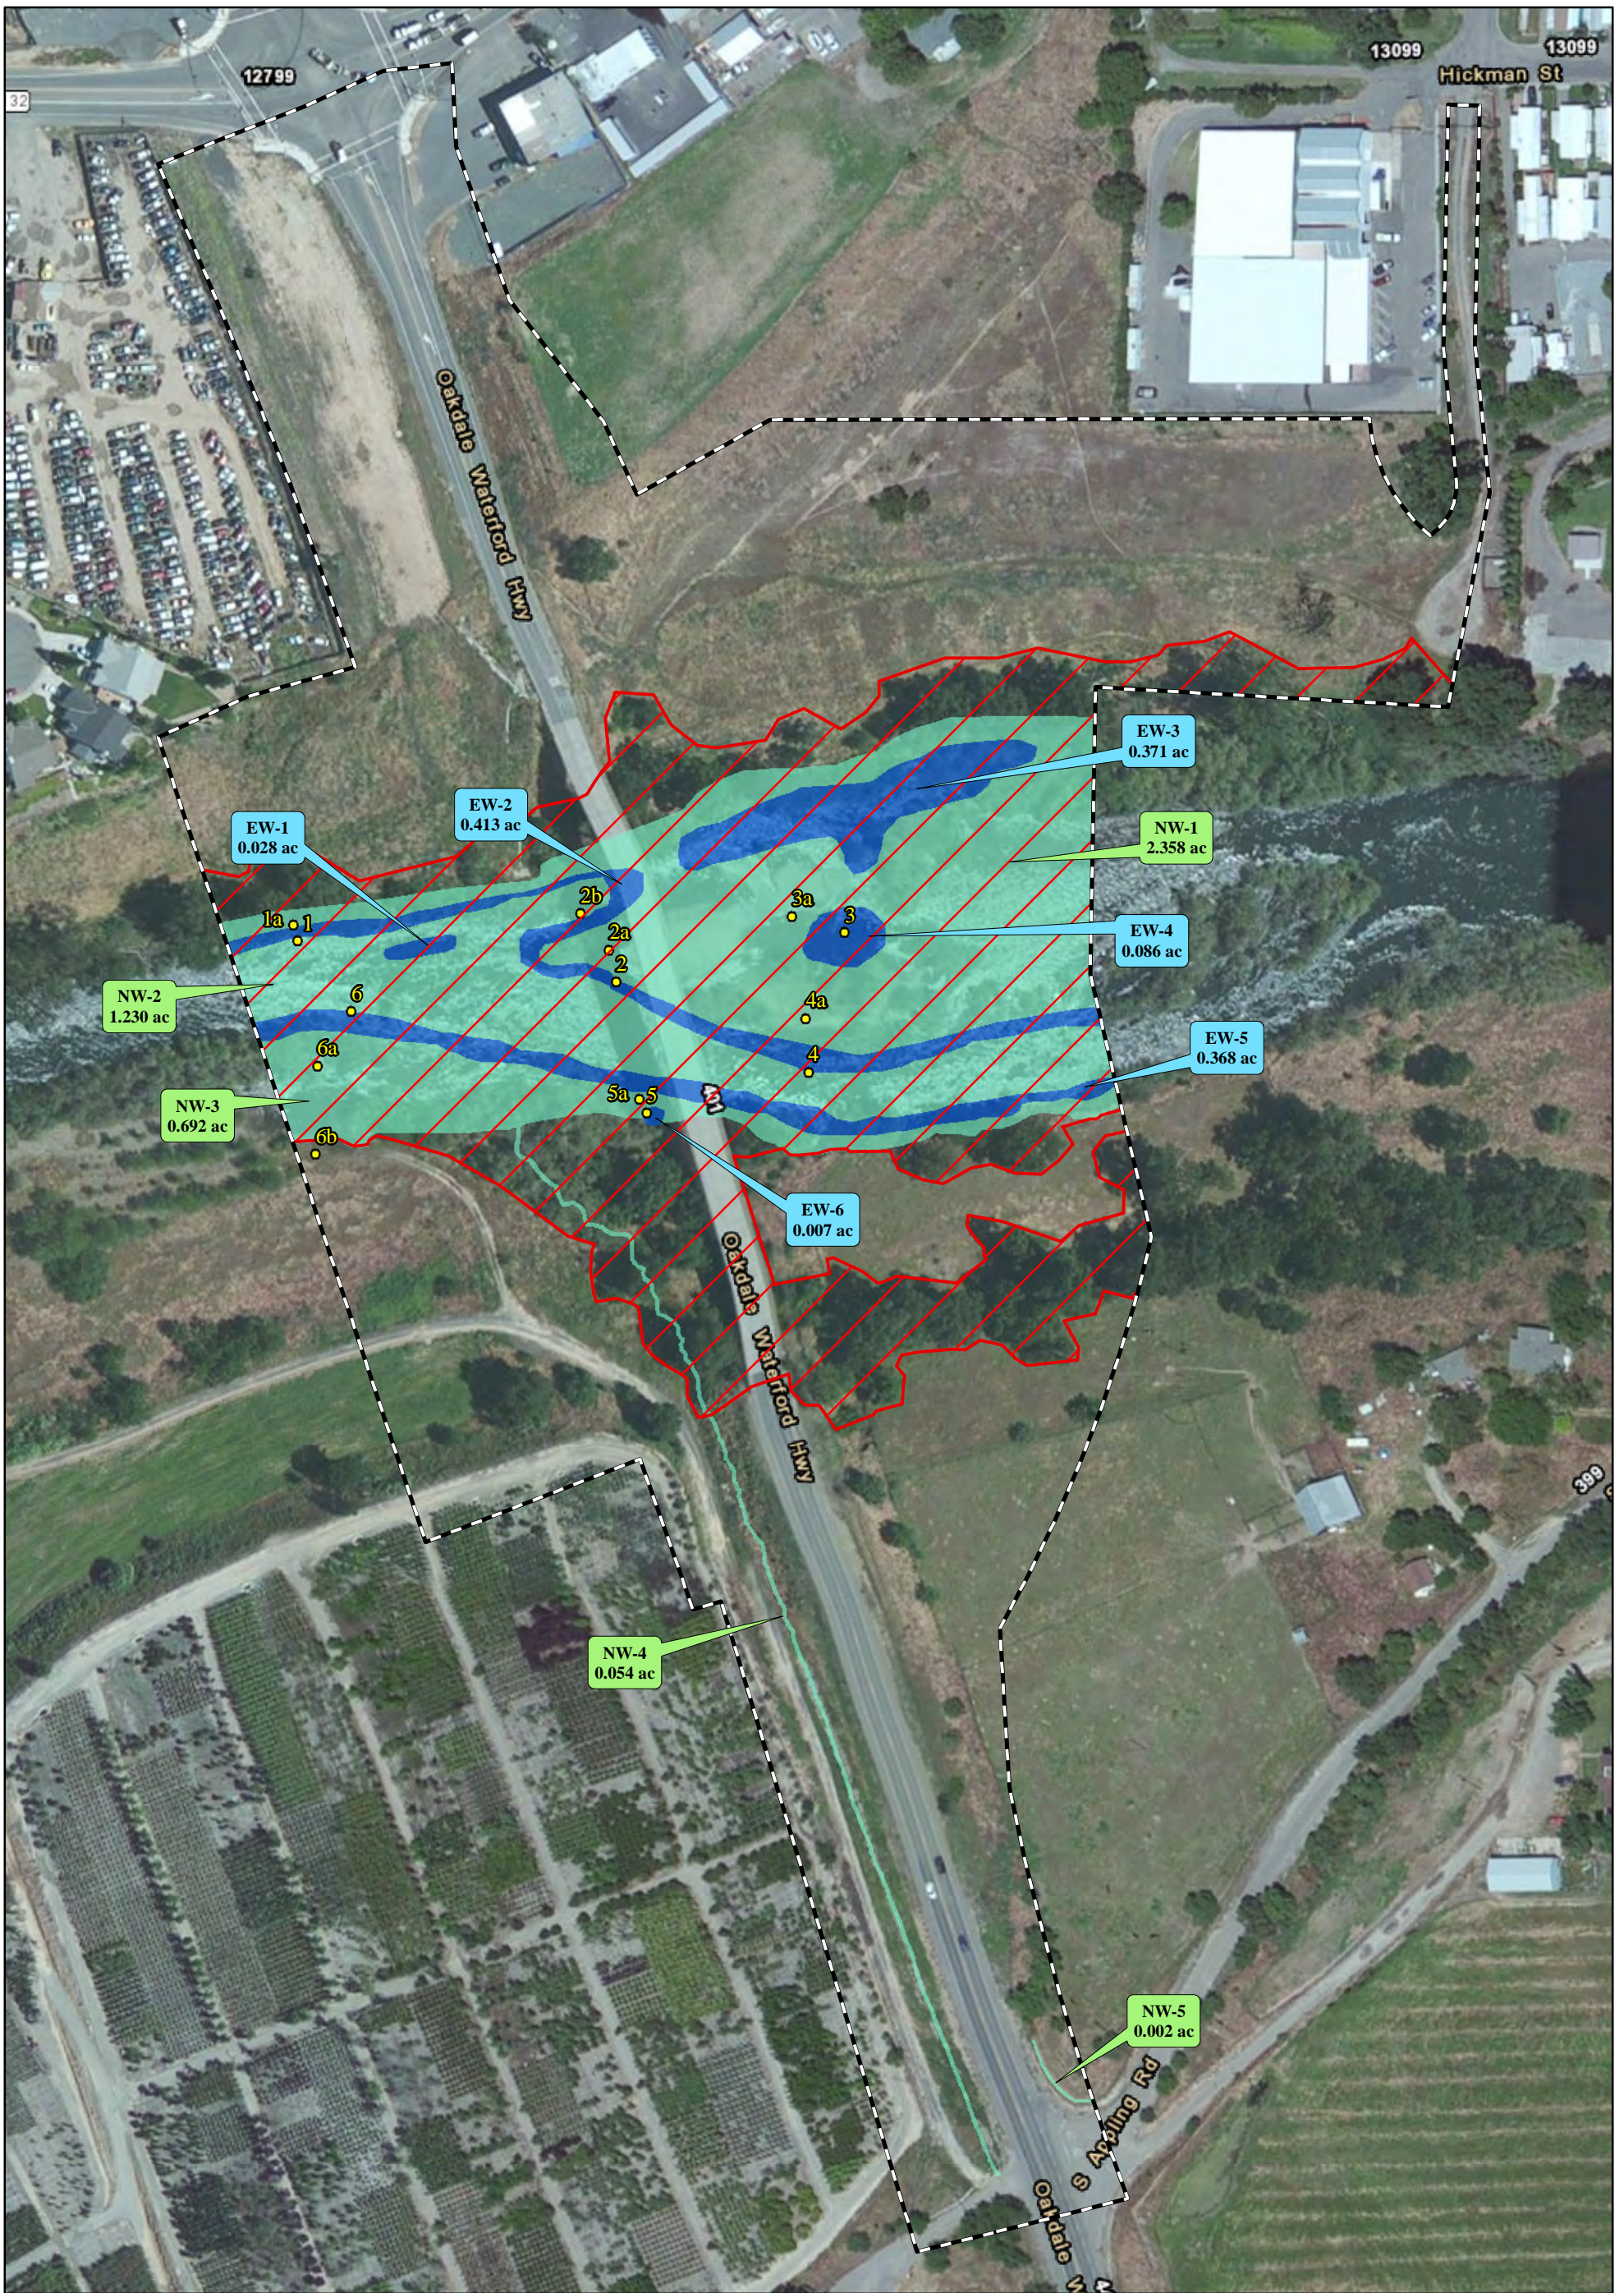
FIGURE 6

Hickman Road Bridge (38C0004) Replacement Project
 Stanislaus County, California
 10-STA-0-CR
 Federal Project No. BRLO-5938 (199)
 Potential Jurisdictional Waters

As noted in Section 2.3, data collection occurred on December 8, 2015; wetland data sheets are included in Appendix C. Figure 6 shows the potential jurisdictional waters in the BSA, which are also summarized below in Table 4.

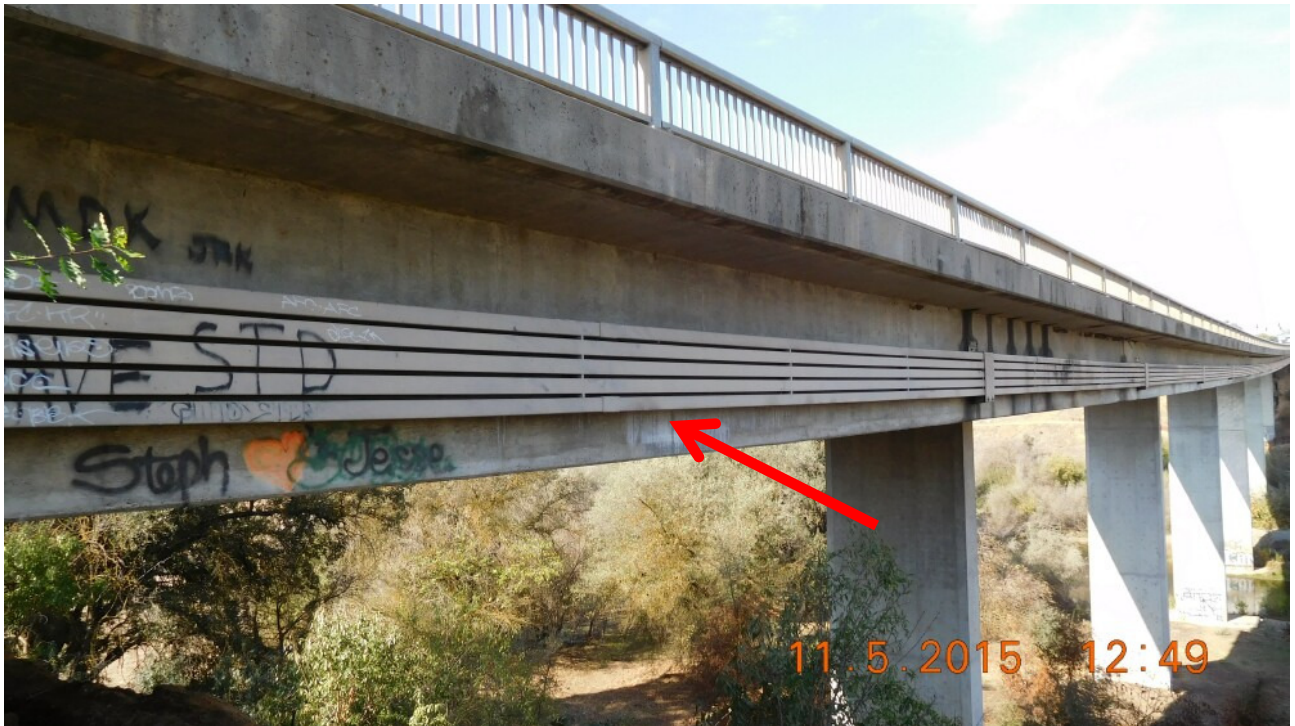
Figure 2. View from south end of bridge. Dead bat observed in roost crevice behind utility channel assembly at arrow.

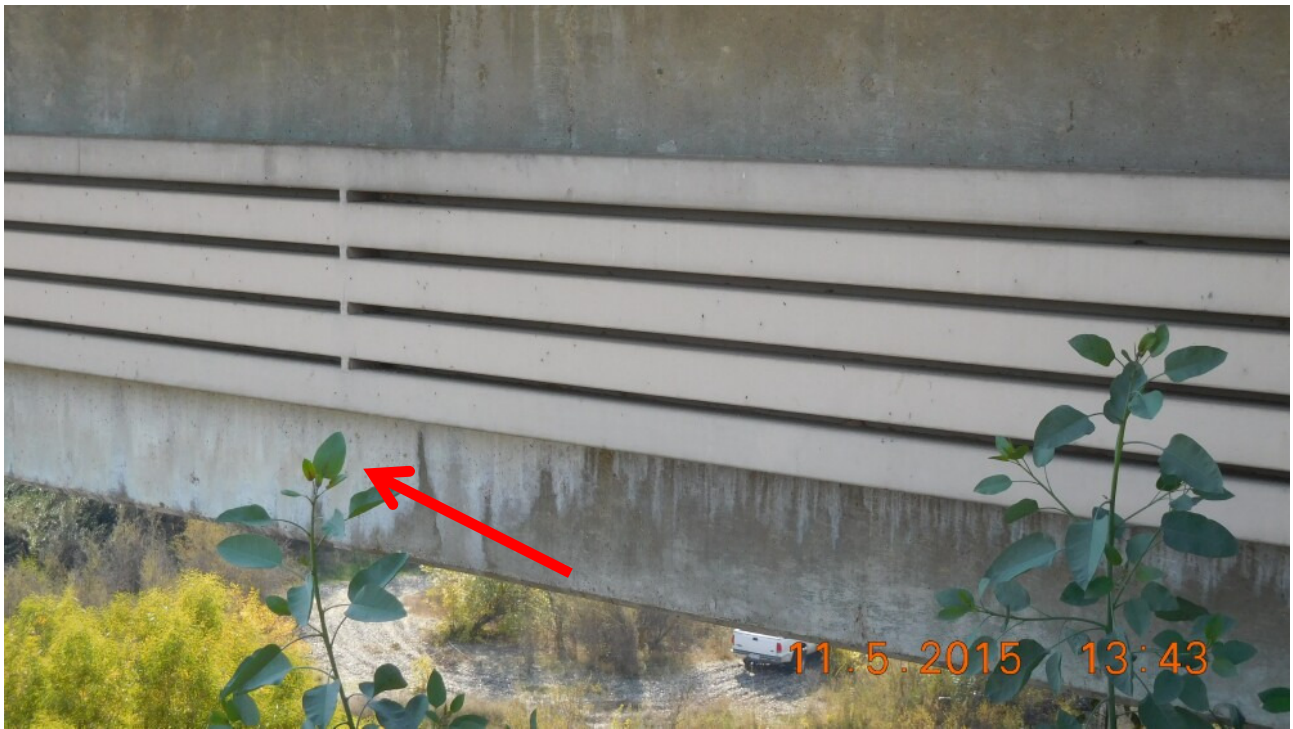
Figure 3. Extensive areas of bat urine staining and bat fecal matter on soffit behind, beneath, and on utility channel assembly.

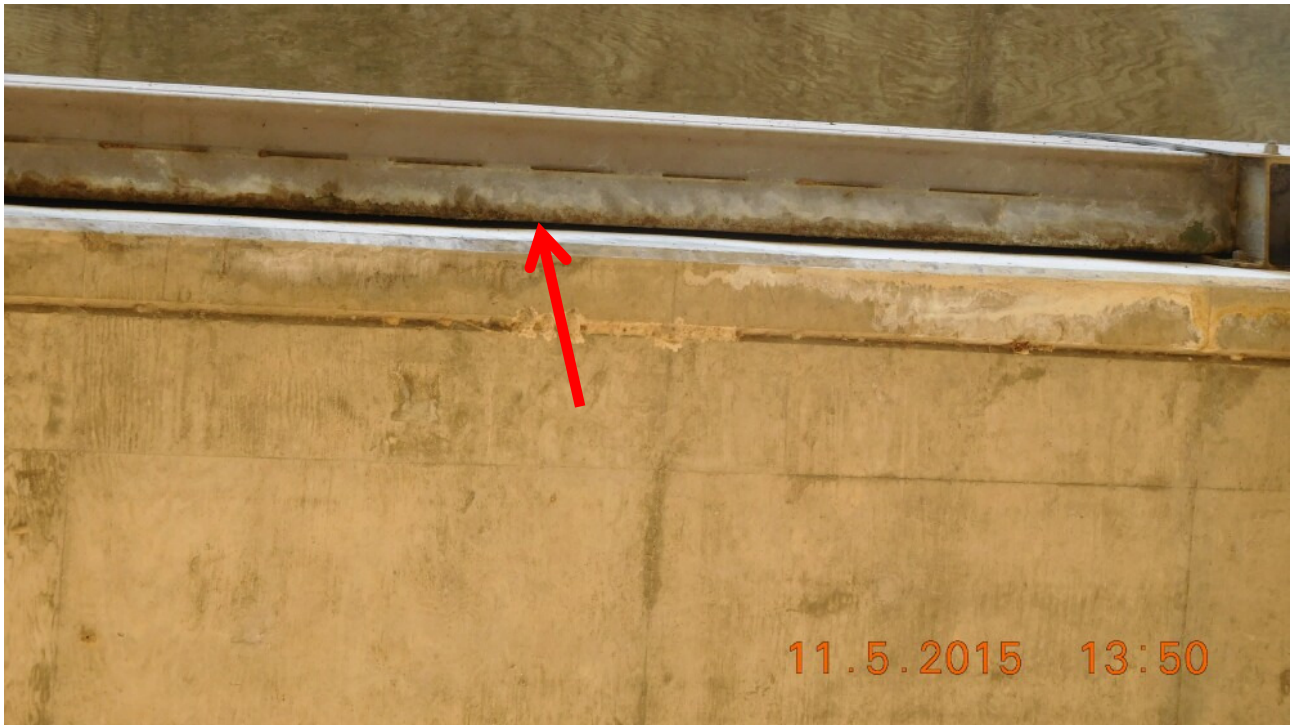
Figure 4. Urine staining indicates use by many bats over many years.

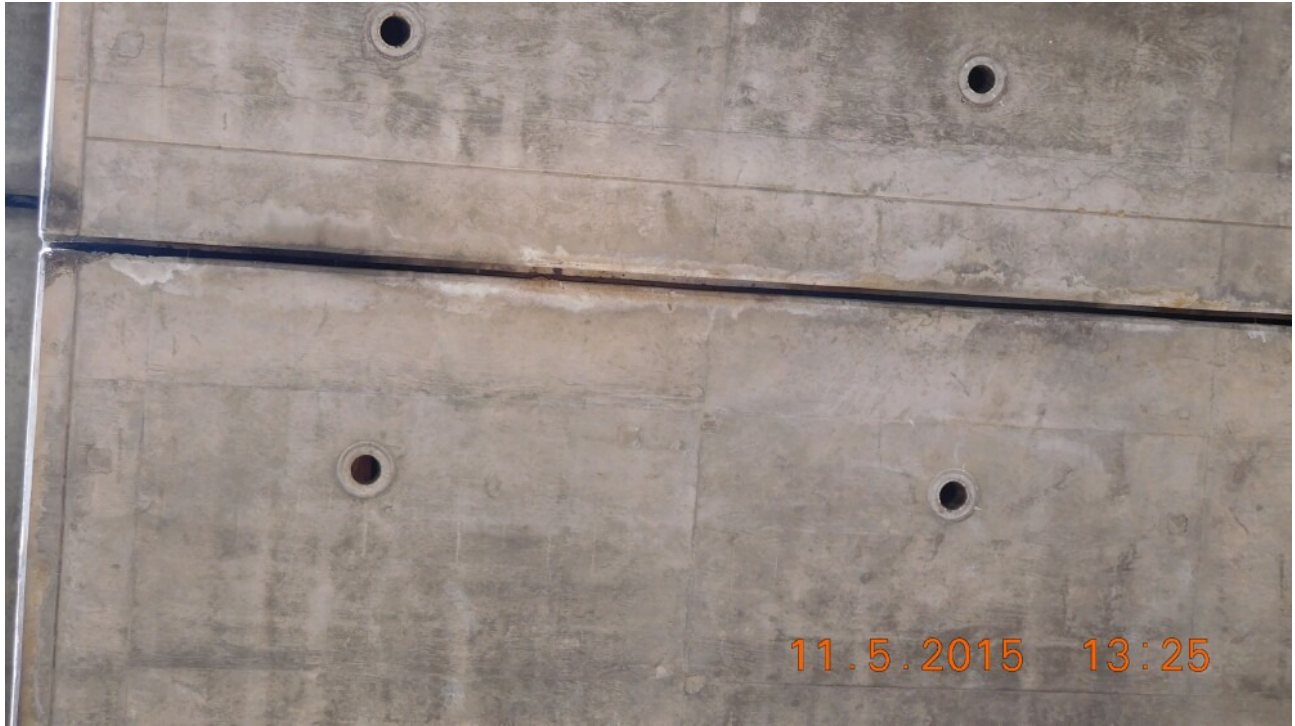
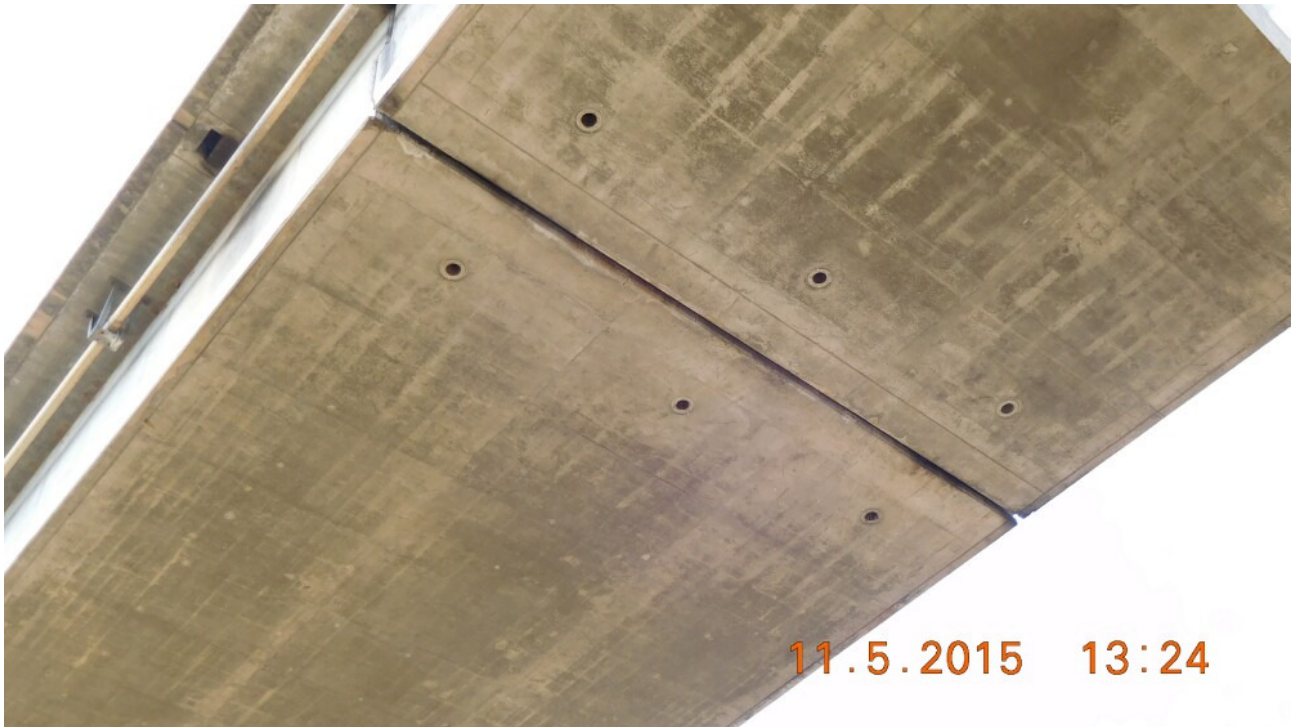
Figure 7. Roosting activity in expansion joints. Unknown whether bats are entering girder interiors through weep holes, but evidence of use by birds was present.

Figure 8. Roosting activity in expansion joints. Unknown whether bats are entering girder interiors through weep holes, but evidence of use by birds was present.

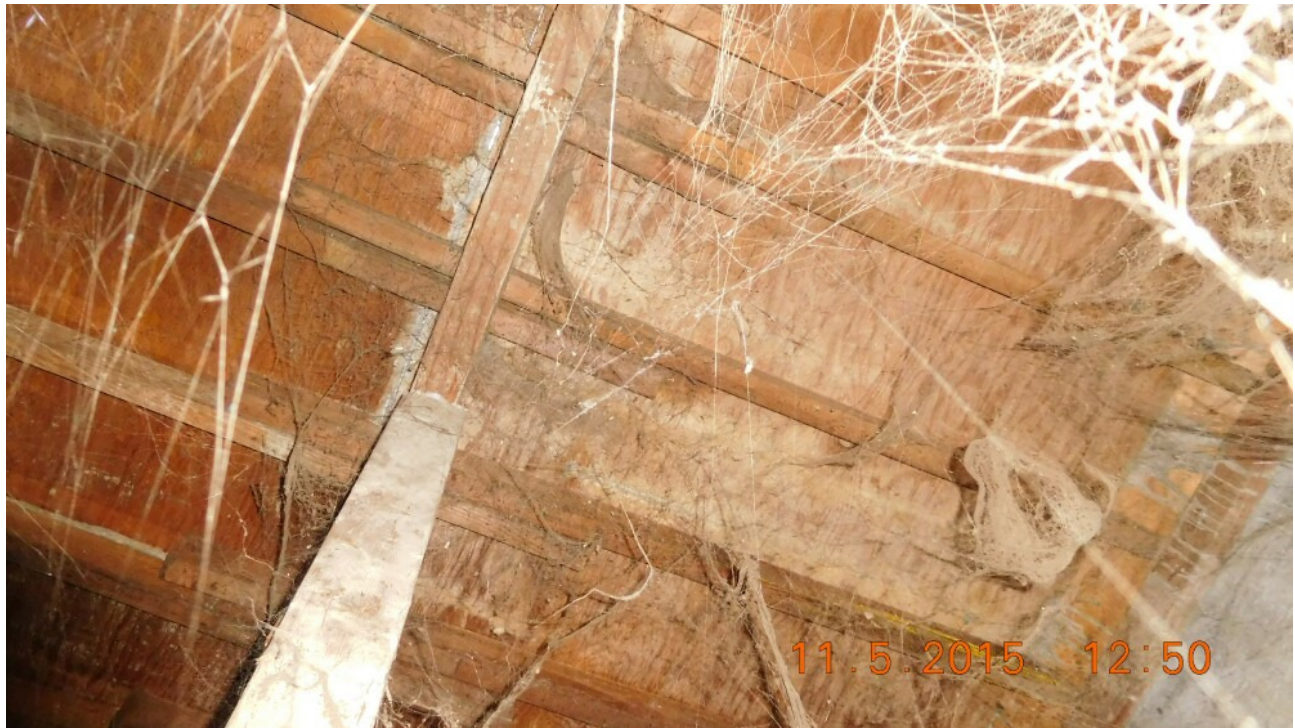
Figure 9. Interior of interior of one girder cell.

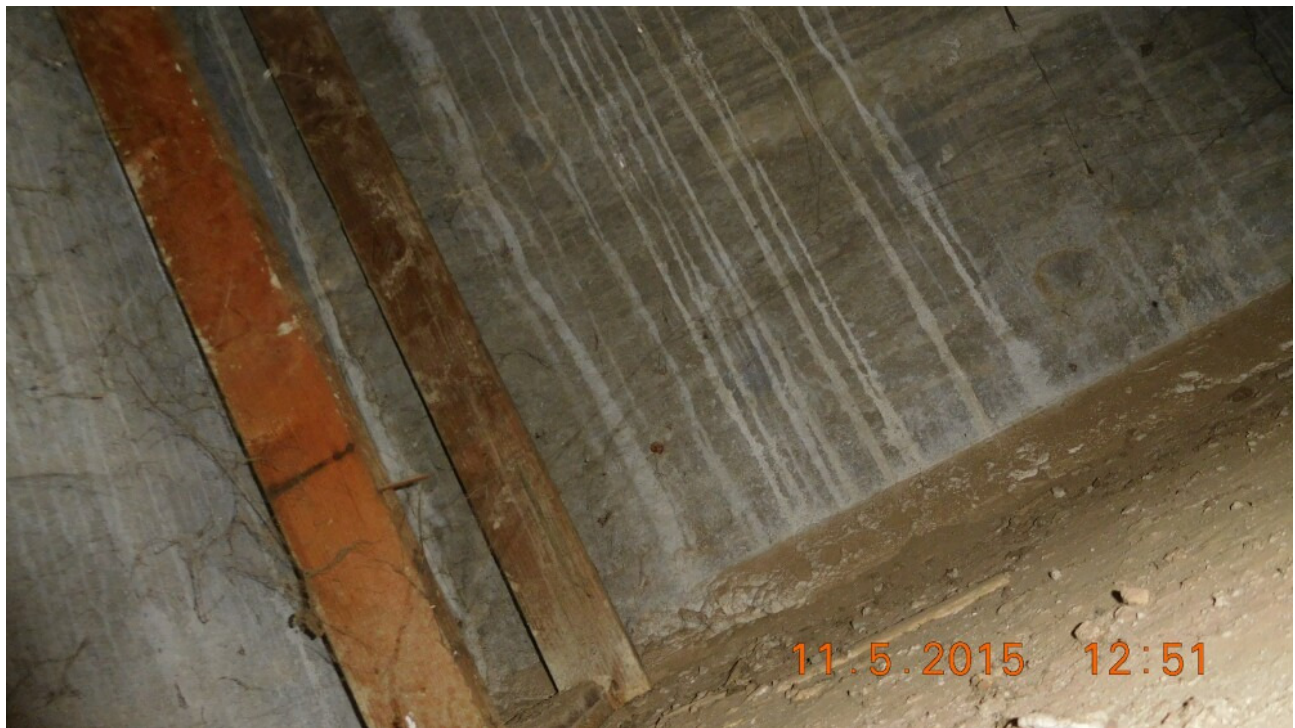
Figure 10. Interior of another girder cell.
